Lagoon Benthic Surveys,

Lough Atalia & Renmore Lough, Galway

Updated Report

Produced by: AQUAFACT – APEM Group

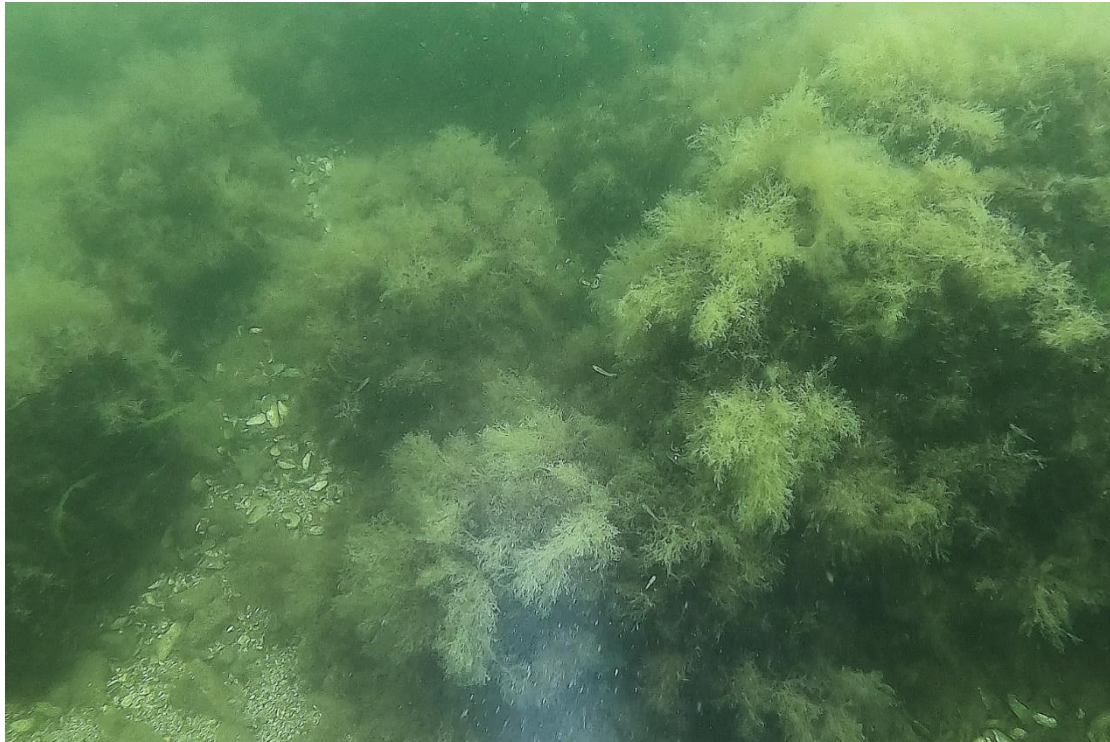
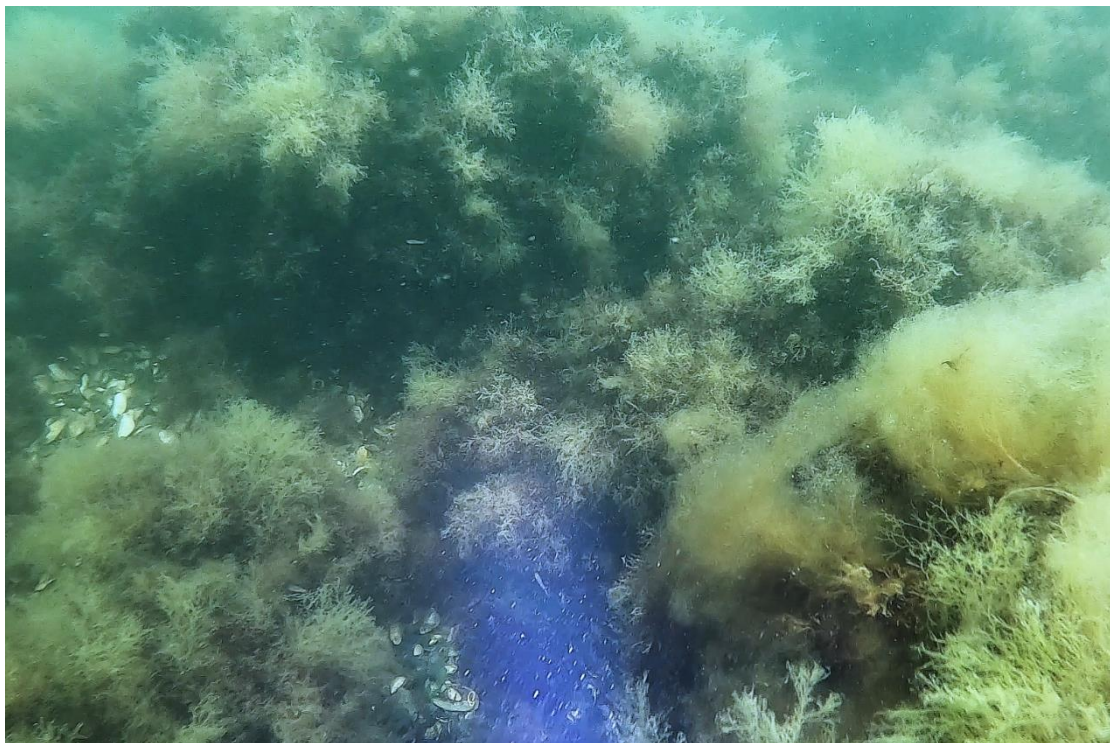
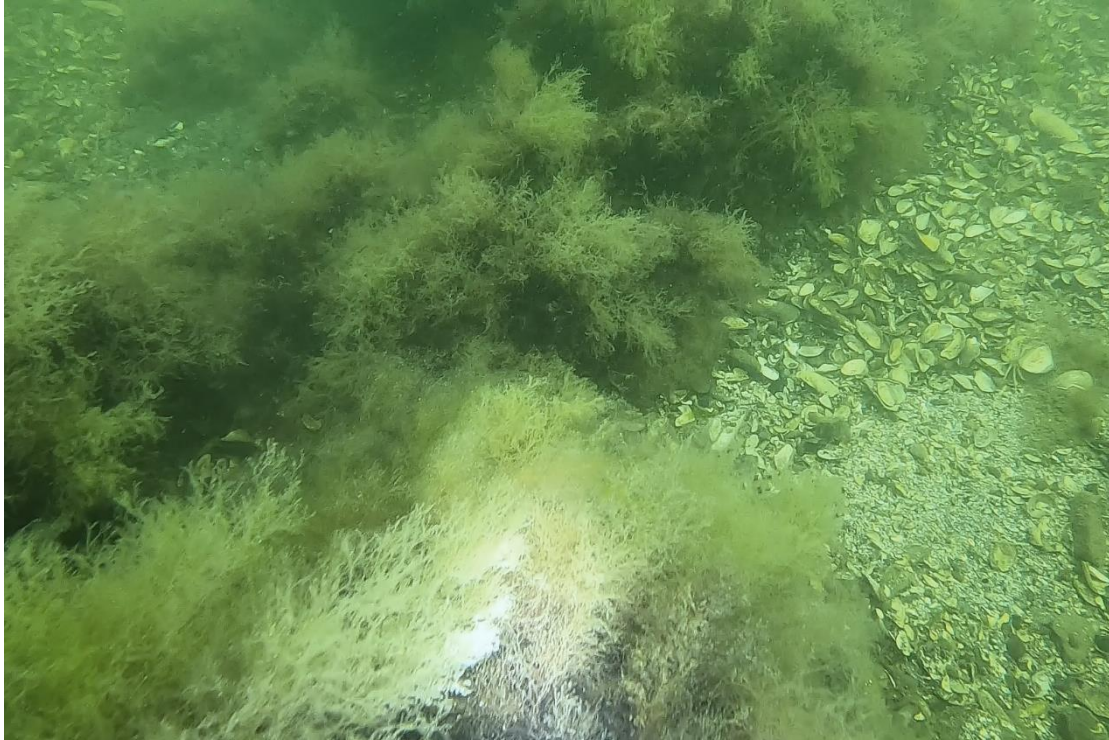
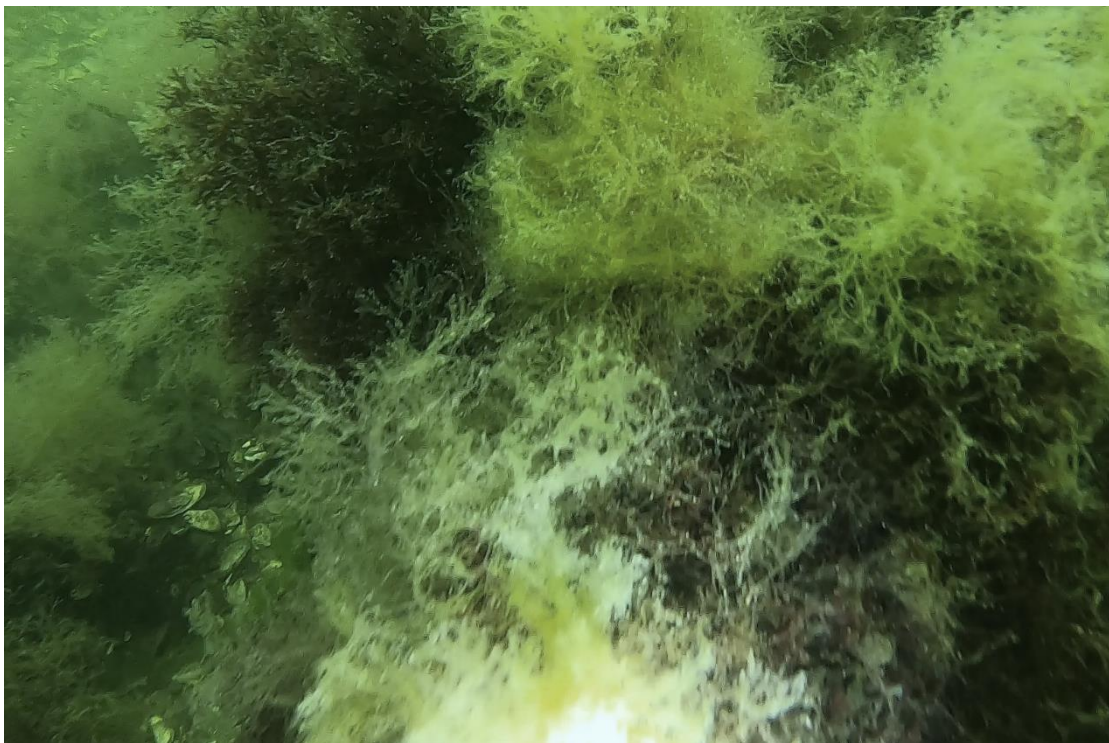
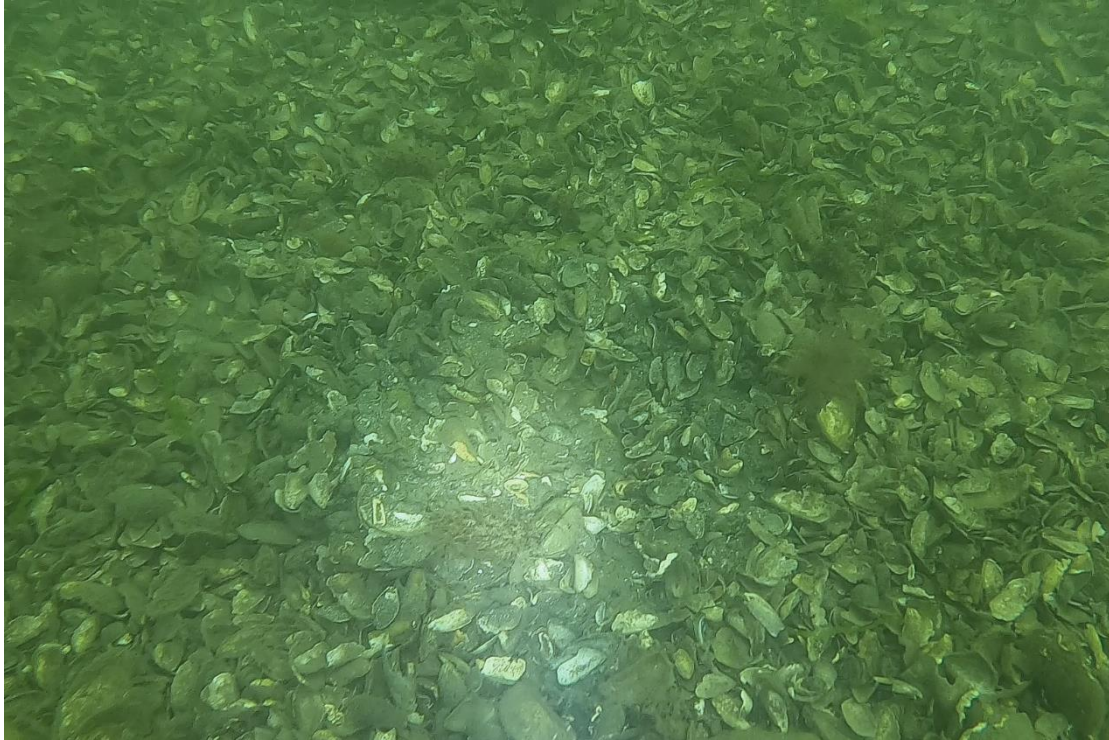
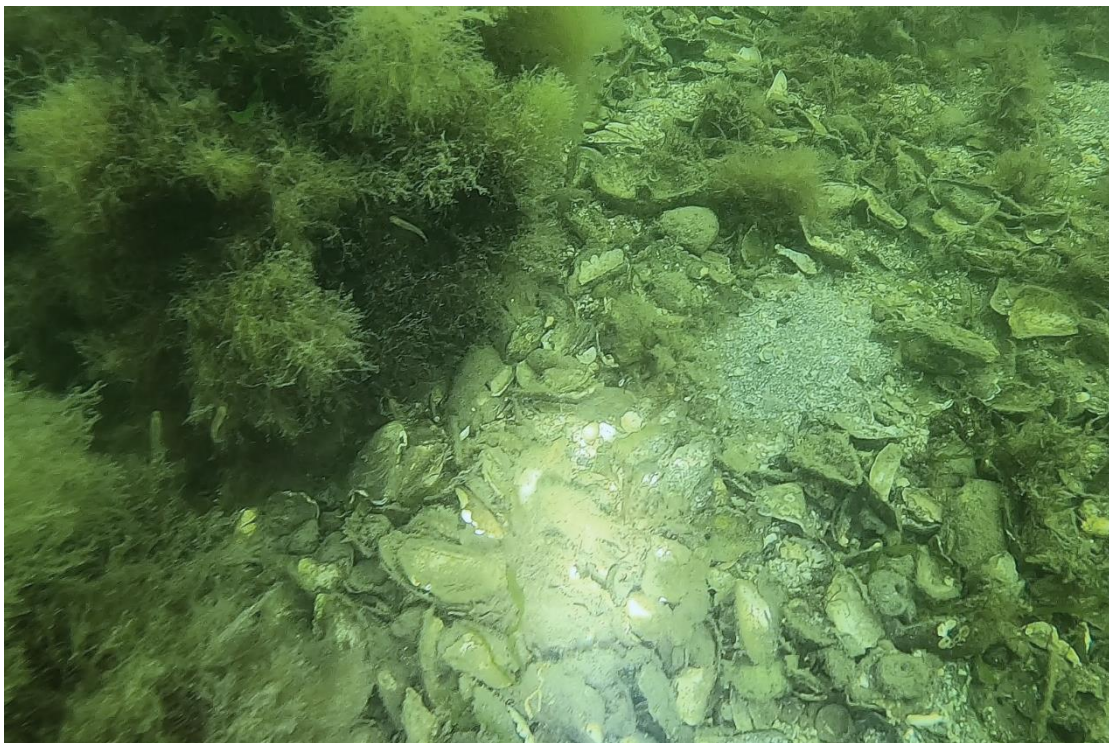
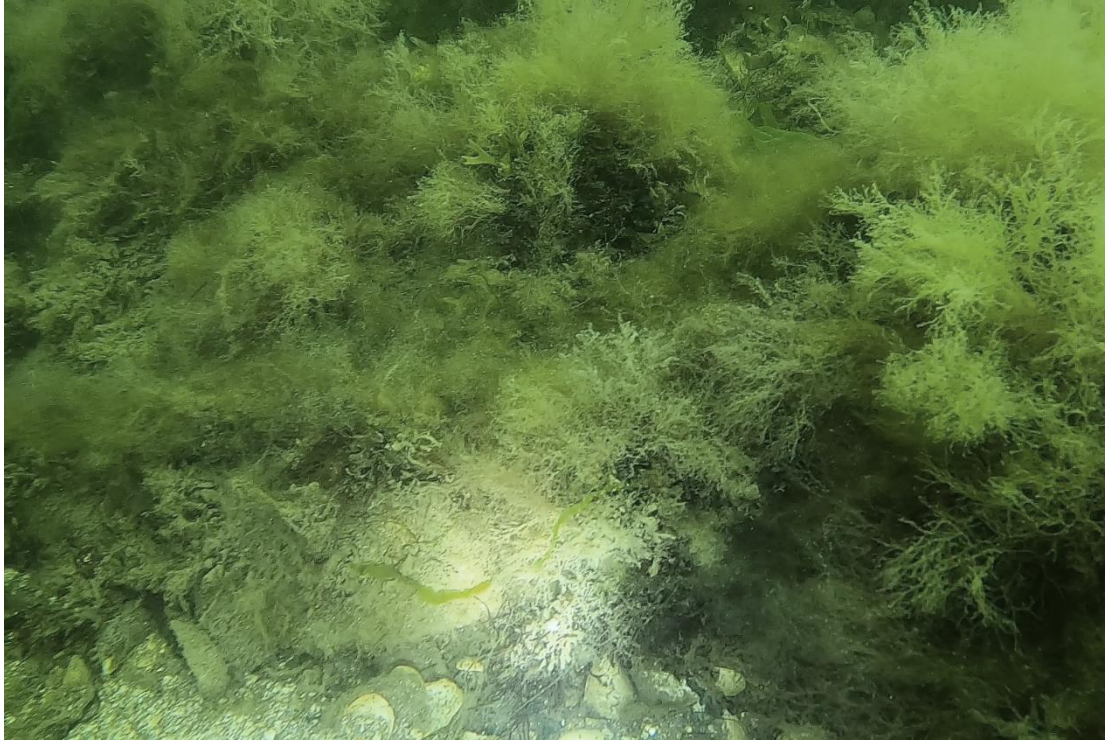
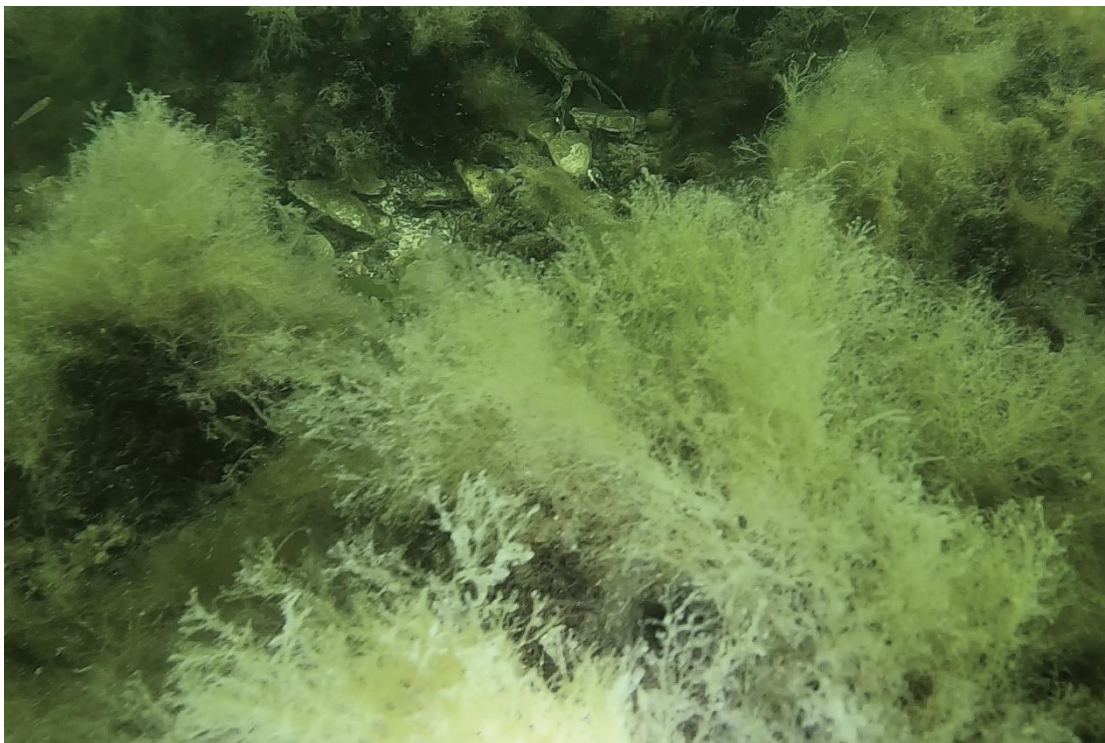
The transect video at station 1 was approximately 2 minutes long. The depth at this station is recorded as approximately 3m below chart datum. The substrate consisted of coarse sand with mussel shell fragments observed throughout. Some boulders were present with fucoids, *Chondrus crispus/Mastocarpus stellatus*, and filamentous algae (possibly *Cladophora* spp. or *Vaucheria*) attached. The sediment surface at this station appeared more oxygenated than the other stations examined in the survey; this is due to the input of seawater flowing into the Lough at a fast rate from Galway Bay. This strong current also influences the substrate with most of the fine mud and silt swept away. As expected, this station had the highest number of faunal taxa recorded, and this mirrors the results of the previous 2013 survey. The species that were observed were a shore crab (*Carcinus maenus*), a velvet crab (*Necora puber*), lug worms casts (*Arenicola marina*), common goby (*Pomatoschistus microps*), a mysid and the tube worm *Spirobranchus* spp. Some drift and decaying algae were observed including *Enteromorpha/Ulva* spp. and *Chaetomorpha linum*.

Figure 3-1: Lough Atalia Station 1.1 Coarse substrate, mussel shell debris. Boulders with epifloral.

Figure 3-2: Lough Atalia Station 1.2 Coarse substrate, mussel shell debris. Boulders with epiflora including filamentous green algae.

Figure 3-3: Lough Atalia Station 1.3 Coarse substrate, shell debris, epiflora.

Figure 3-4: Lough Atalia Station 1.4 Boulders with epiflora including *Chondrus crispus*/*Mastocarpus*.

Figure 3-5: Lough Atalia Station 1.5 Extensive mussel shell debris on sea bed.

Figure 3-6: Lough Atalia Station 1.6 Coarse sediment, mussel shell debris, *Arenicola marina* casts and epiflora on boulders.

Figure 3-7: Lough Atalia. Station 1.7 Coarse sediment, mussel shell debris, and epiflora on boulders.

Figure 3-8: Station 1.8 Mussel shell debris with encrusting calcareous polychaetes.

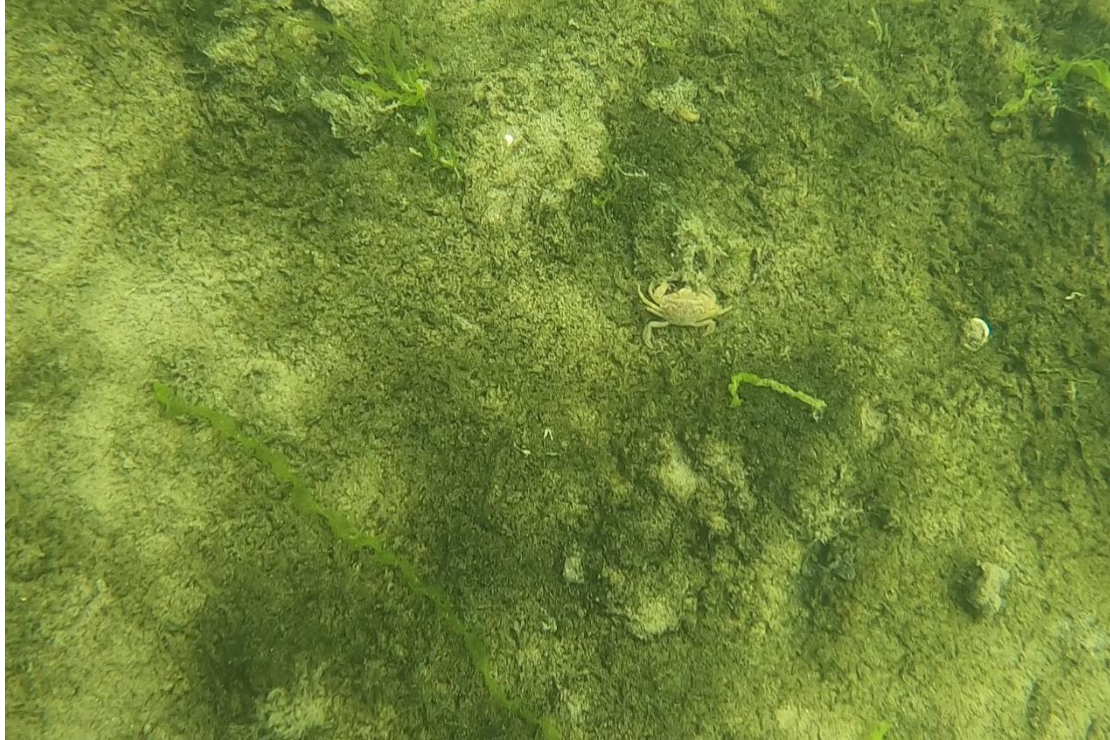
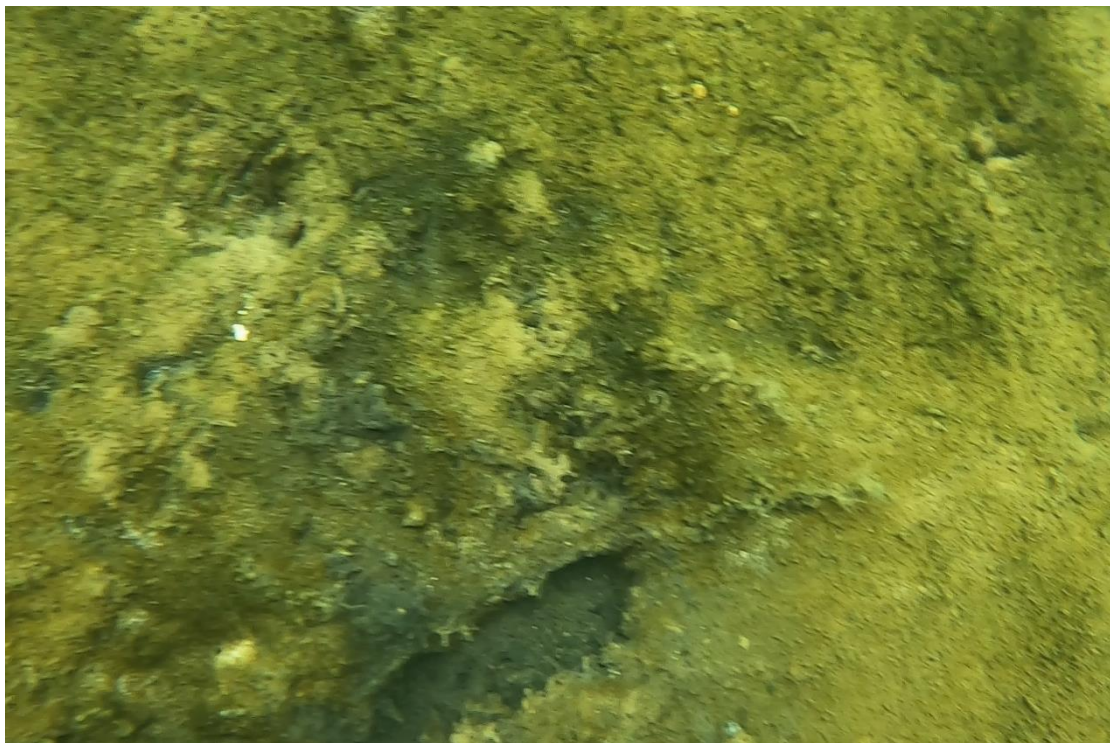
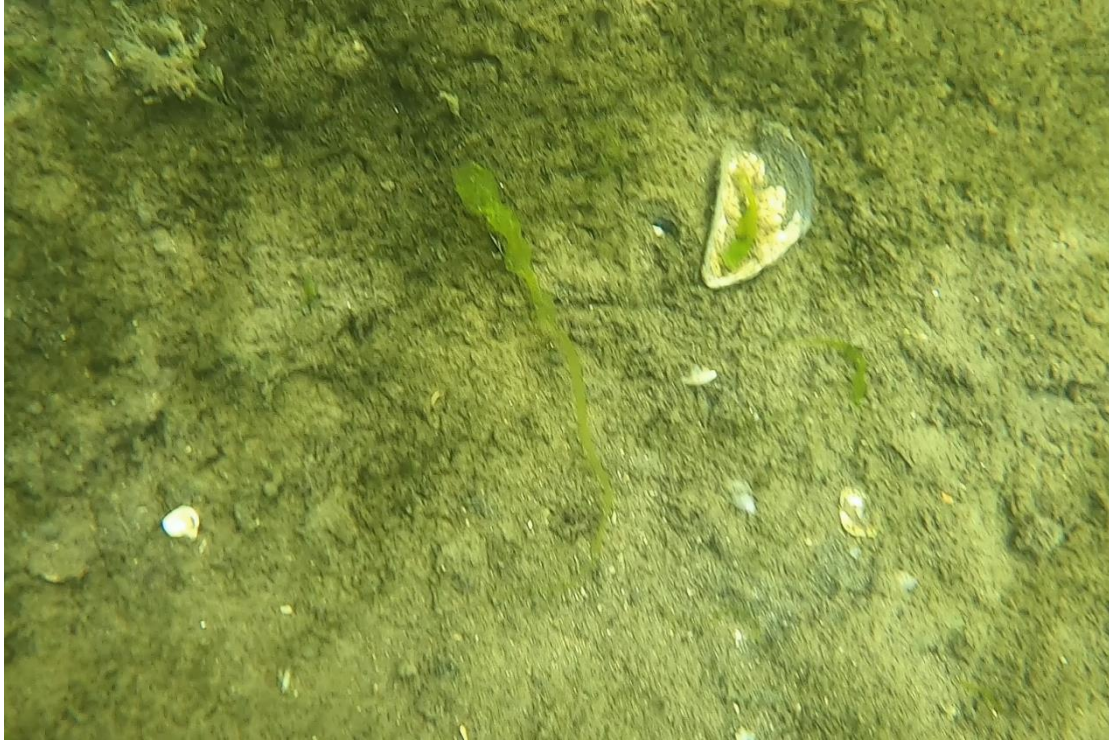
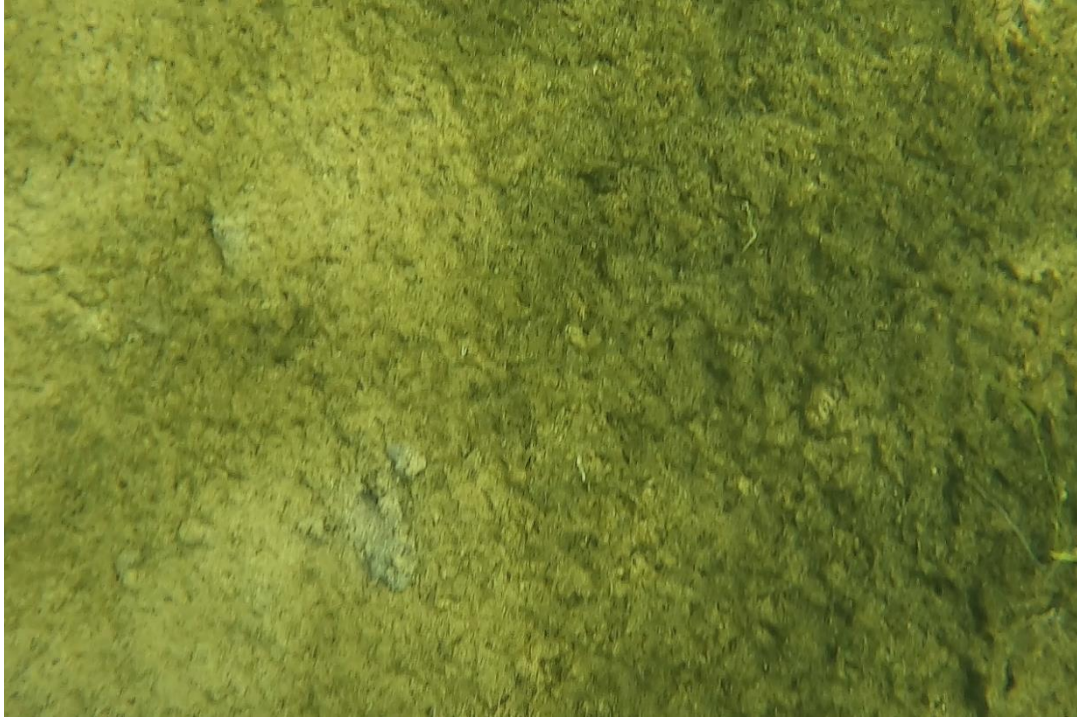
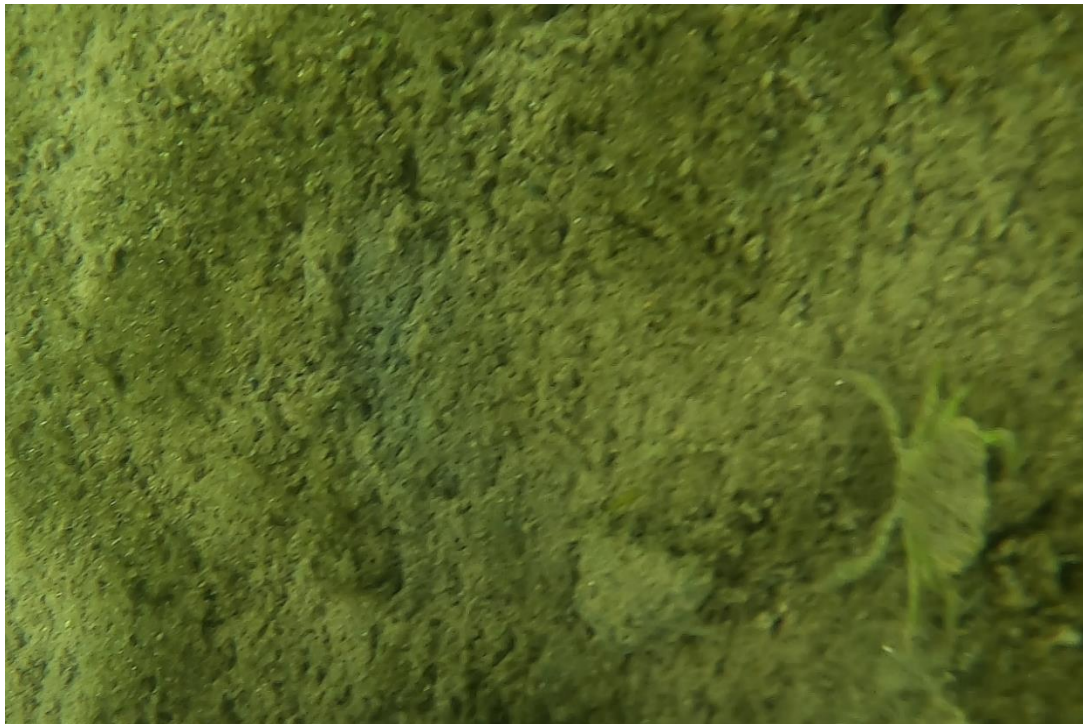
The duration of the video transect at station 2 was approximately 2 minutes long. The depth at this station has been recorded at less than 1m below chart datum. The substrate consisted of thick mud with a surface layer of benthic diatoms and scattered shell debris. While the surface for the most part seemed oxygenated, it was apparent wherever the surface was disturbed that anoxic sediment was immediately below. This is as a result of the high organic enrichment throughout Lough Atalia. There were also small patches of *Beggiatoa* bacterial mats – further signs of the anoxic conditions on the seabed. There were few records of fauna present. A couple of shore crabs (*Carcinus maenus*) were recorded and the evidence of their movements in the area can be seen in the numerous tracks across the surface of the mud. Mussel shell fragments were also observed. Some drift and decaying algae were observed including *Enteromorpha/Ulva* spp.

Figure 3-9: Lough Atalia Station 2.1 Soft mud with benthic diatom and shell debris.

Figure 3-10: Lough Atalia Station 2.2 Soft mud, benthic diatoms, *Enteromorpha/Ulva*, and *Carcinus maenus*.

Figure 3-11: Lough Atalia Station 2.3. Soft mud with disturbed sediment exposing anoxic subsurface conditions.

Figure 3-12: Lough Atalia Station 2.4. Soft mud, mussel shell debris, and *Enteromorpha/Ulva*.

Figure 3-13: Lough Atalia Station 2.5 Soft mud with benthic diatoms.

Figure 3-14: Lough Atalia Station 2.6 Soft mud with benthic diatoms

Figure 3-15: Lough Atalia Station 2.7 Soft mud with benthic diatoms and *Carcinus maenus*.

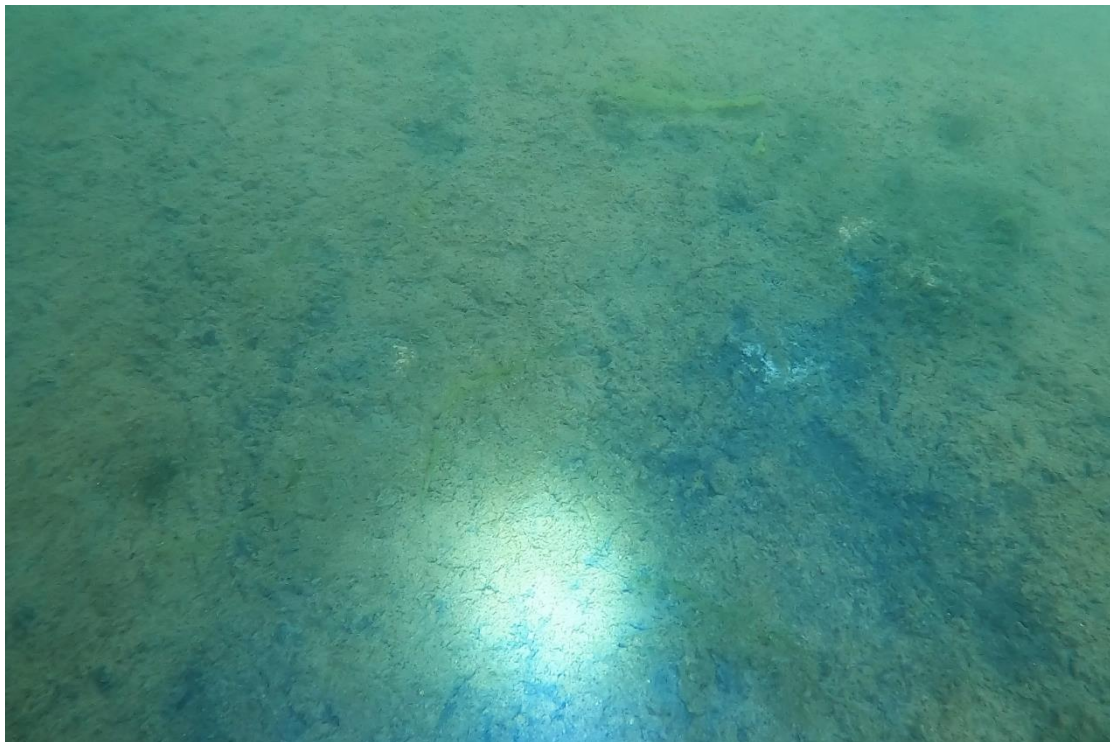
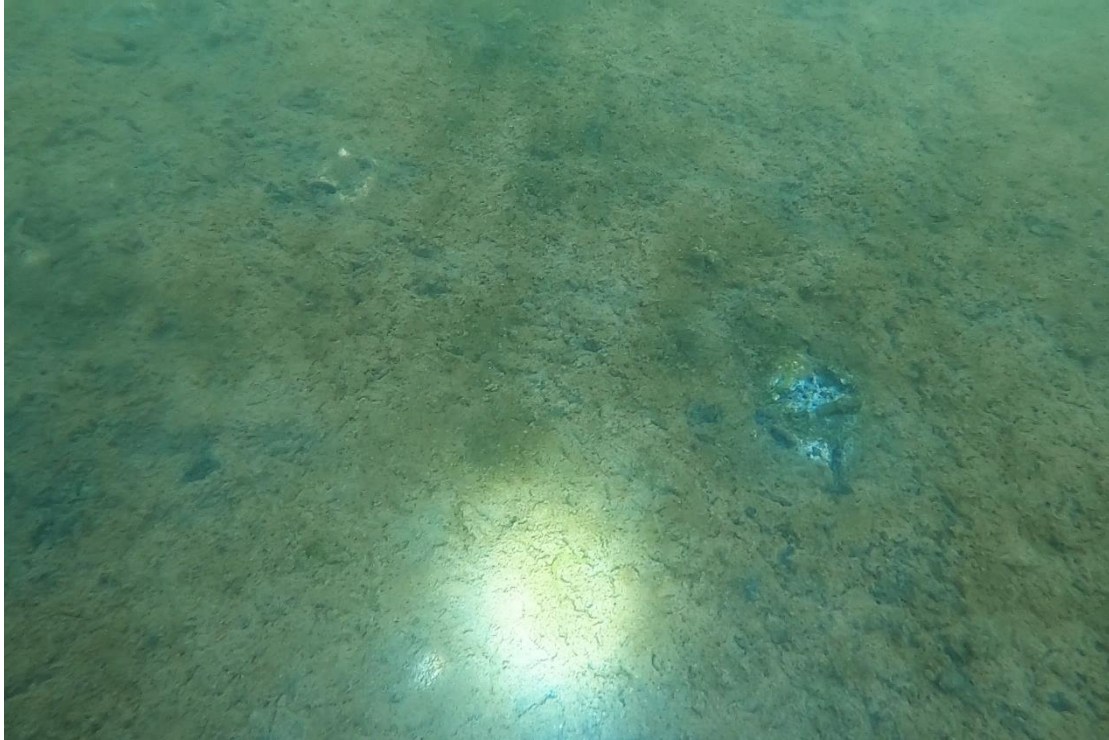
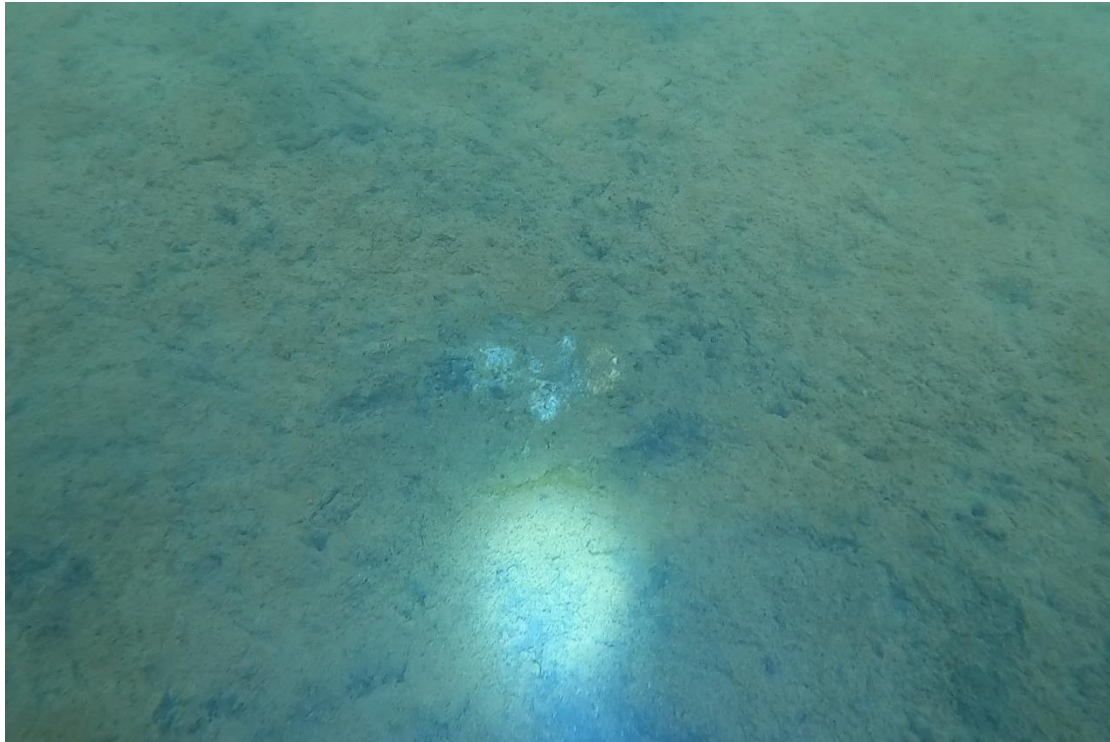
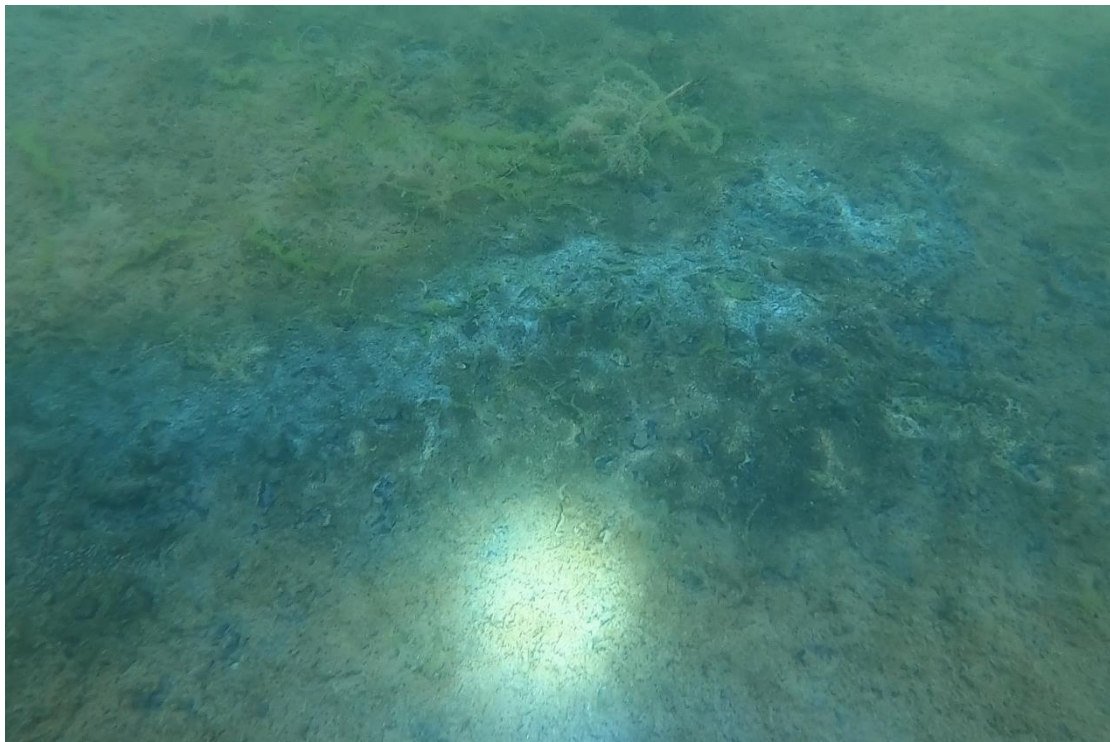
The duration of the video transect at station 3 was approximately 2 minutes long. The depth at this station was recorded at less than 1m below chart datum. The substrate consisted of thick mud with a surface layer of benthic diatoms. While the surface for the most part seemed oxygenated, it was apparent wherever the surface was disturbed that anoxic sediment was immediately below. This is as a result of the high organic enrichment throughout Lough Atalia. As recorded in Station 2 there were also more extensive patches of *Beggiatoa* bacterial mats – further signs of the anoxic conditions on the seabed. There were few records of fauna present. No fauna was recorded but evidence of the movements of crabs in areas can be seen in the numerous tracks across the surface of the mud. Some drift and decaying algae were observed including *Enteromorpha/Ulva* spp and *Chaetomorpha linum*.

Figure 3-16: Lough Atalia Station 3.1. Soft mud with anoxic sediment and *Beggiatoa* visible.

Figure 3-17: Lough Atalia Station 3.2 Soft mud with benthic diatoms, *Beggiatoa* and anoxic sediment.

Figure 3-18: Lough Atalia Station 3.3. 2 Soft mud with benthic diatoms. Tracks of mobile surface fauna visible.

Figure 3-19: Lough Atalia Station 3.4. Soft mud with benthic diatoms, *Beggiatoa*, *Enteromorpha/Ulva* and anoxic sediment.

Figure 3-20: Lough Atalia Station 3.5. Soft mud with decaying green algae, *Beggiatoa*, and benthic diatoms.

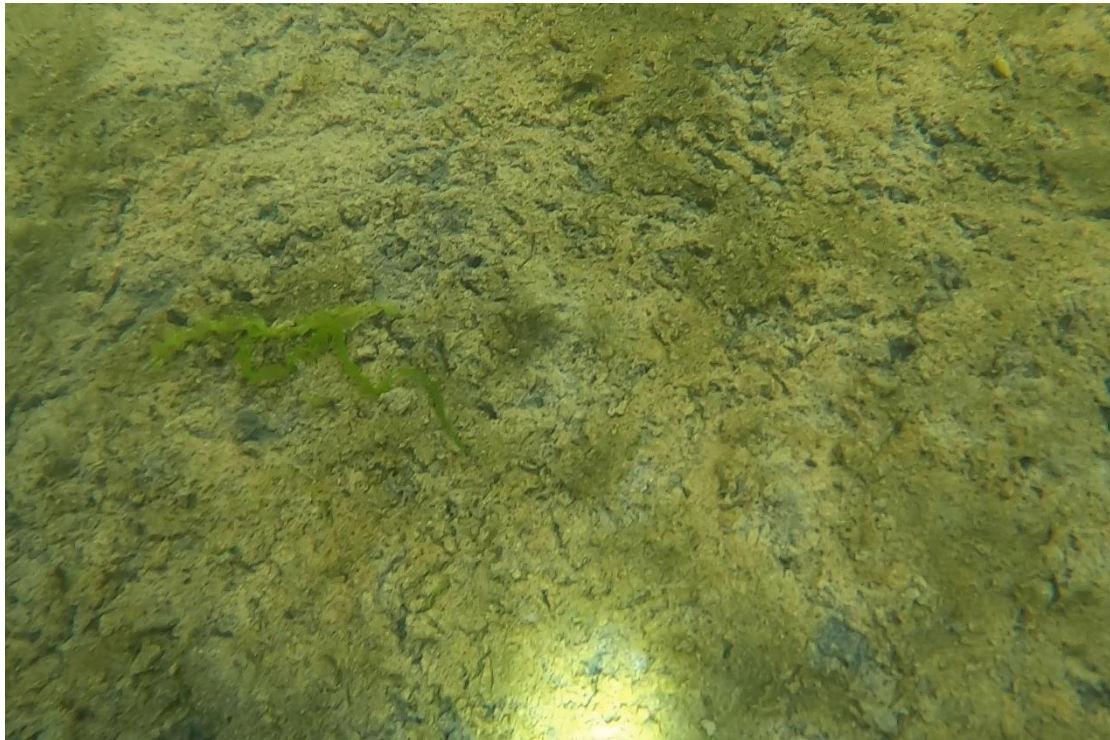
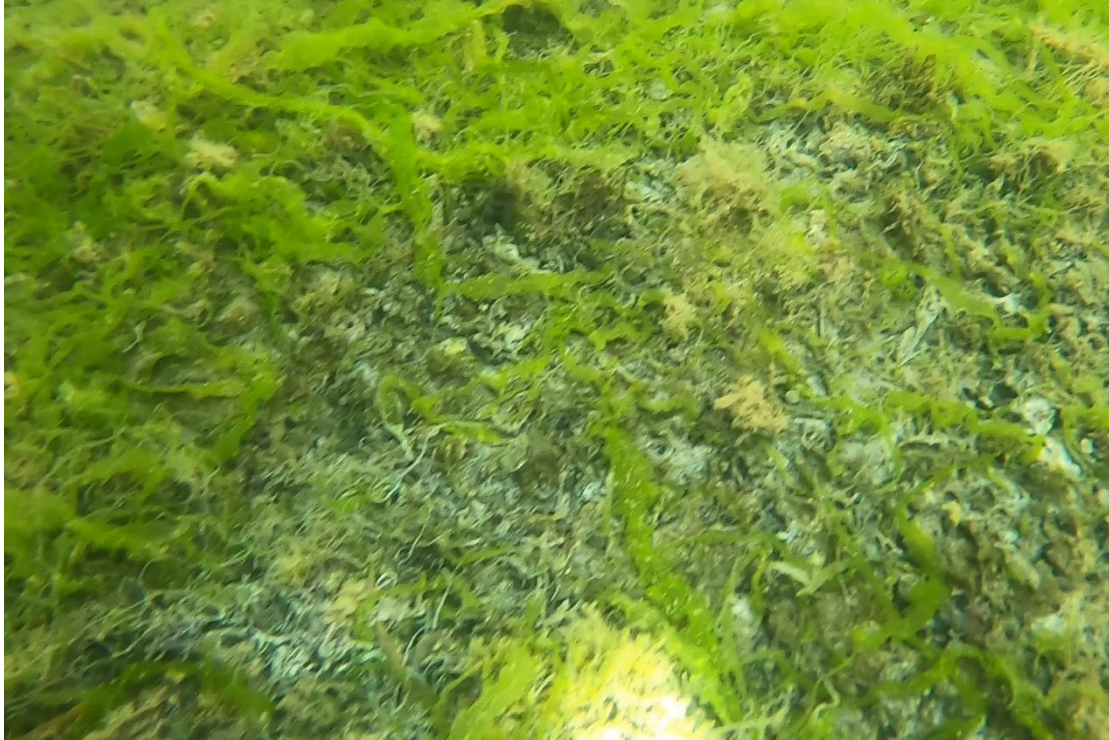
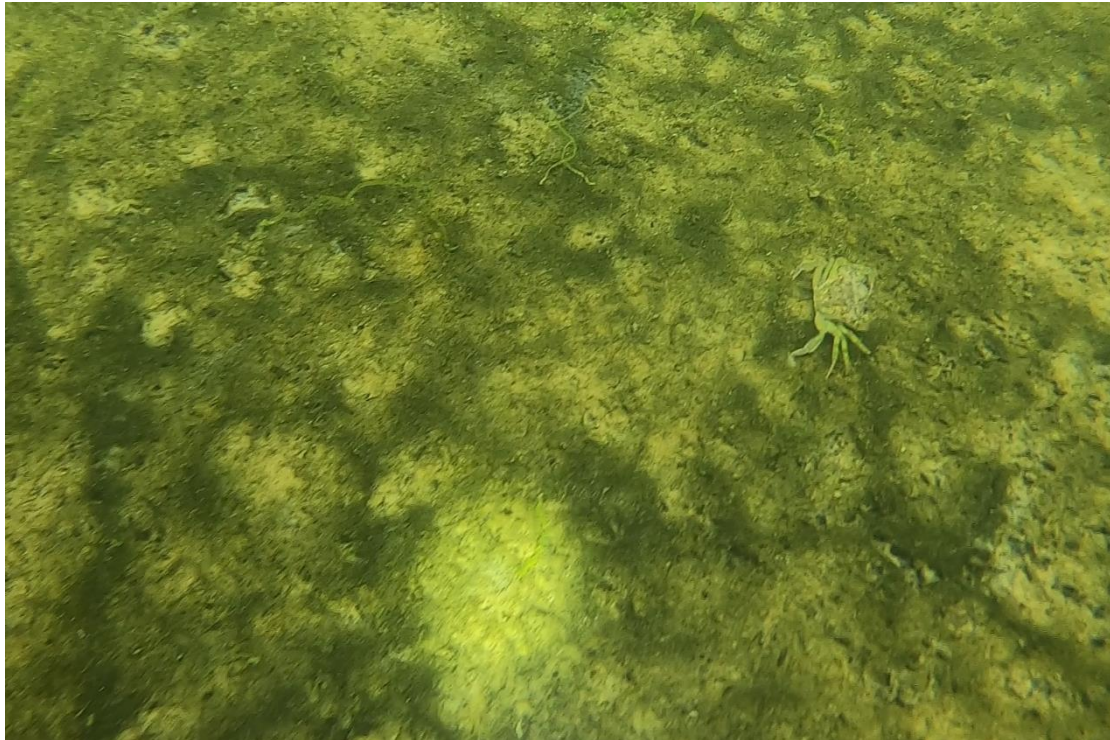
The duration of video transect at station 4 was approximately 2 minutes long. The depth at this station has been recorded at less than 1m below chart datum. The substrate consisted of thick mud with a surface layer of benthic diatoms. While the surface again appears oxygenated, as in the majority of the other stations it was apparent wherever the surface was disturbed that anoxic sediment was immediately below. Small patches of *Beggiatoa* bacterial mats were again recorded as were patches of drift and decaying algae, primarily *Enteromorpha/Ulva*. There were few records of fauna present. A couple of shore crabs (*Carcinus maenus*) were recorded and the evidence of their movements in the areas can be seen in the numerous tracks across the surface of the mud.

Figure 3-21: Lough Atalia Station 4.1 Soft mud with benthic diatoms, anoxic sediment and *Enteromorpha/Ulva*. Tracks of mobile surface fauna also visible.

Figure 3-22: Lough Atalia Station 4.2. *Enteromorpha/Ulva* and patchy *Beggiatoa* on muddy substrate.

Figure 3-23: Lough Atalia Station 4.3. Tracks of mobile surface fauna visible on the muddy surface. Tracks of mobile fauna visible.

Figure 3-24: Lough Atalia Station 4.4. Shore crab *Carcinus maenus* on a muddy substrate with surface benthic diatoms.

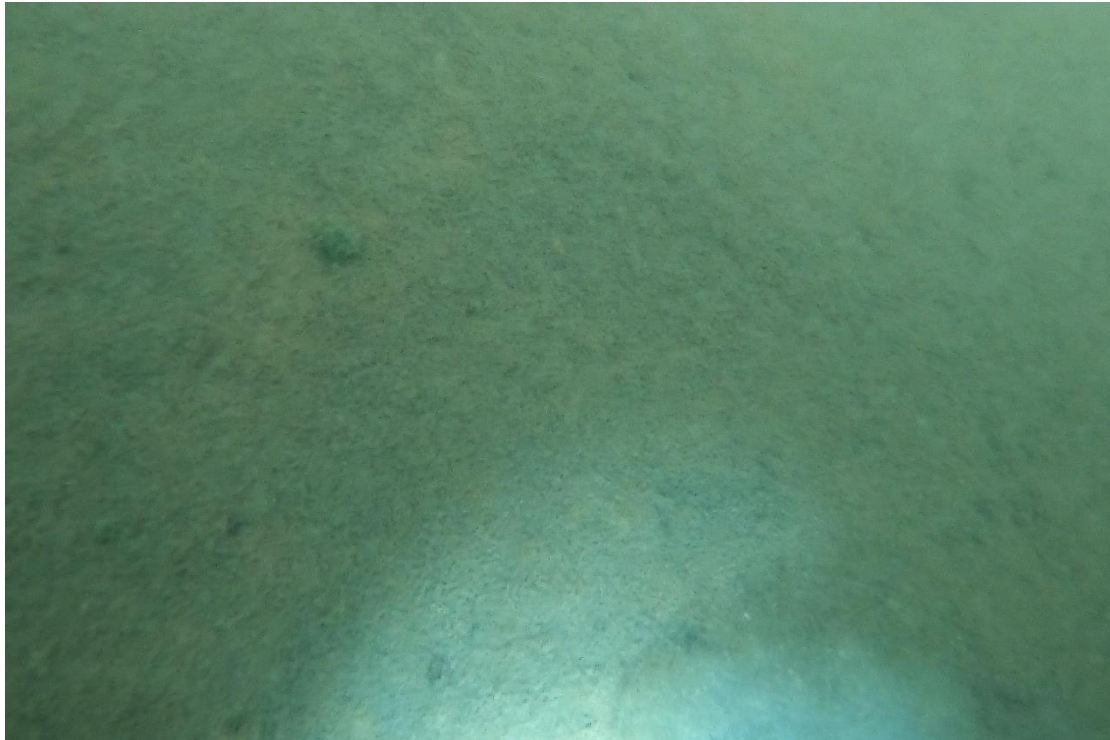
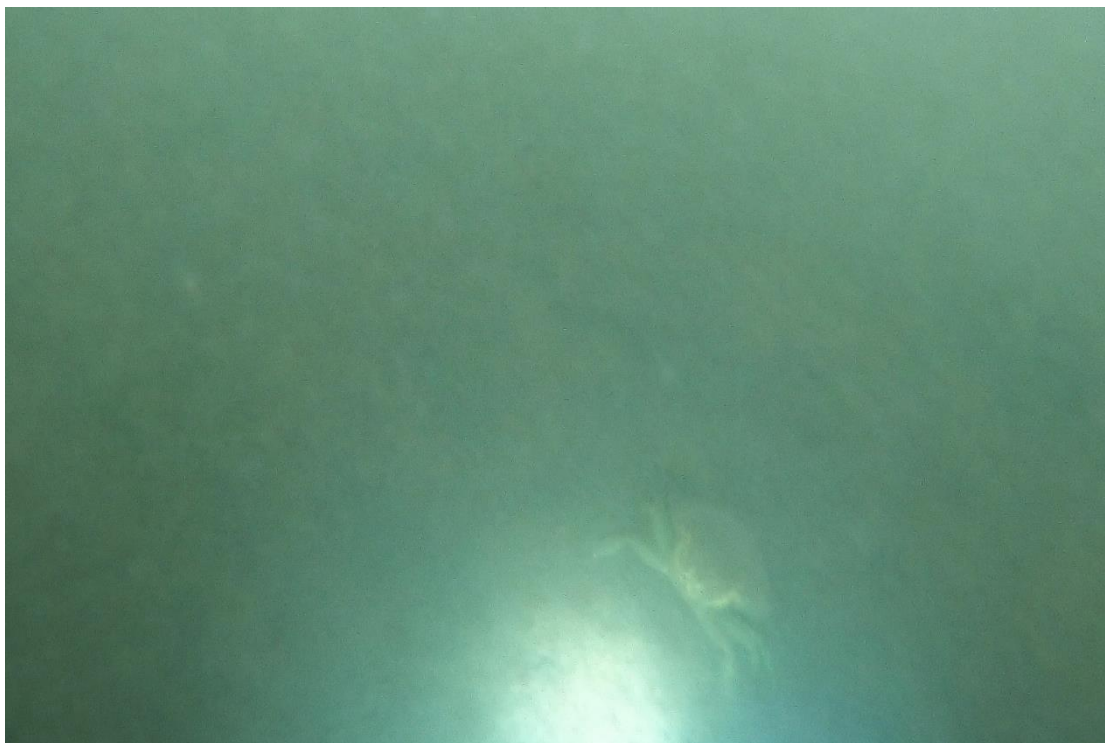
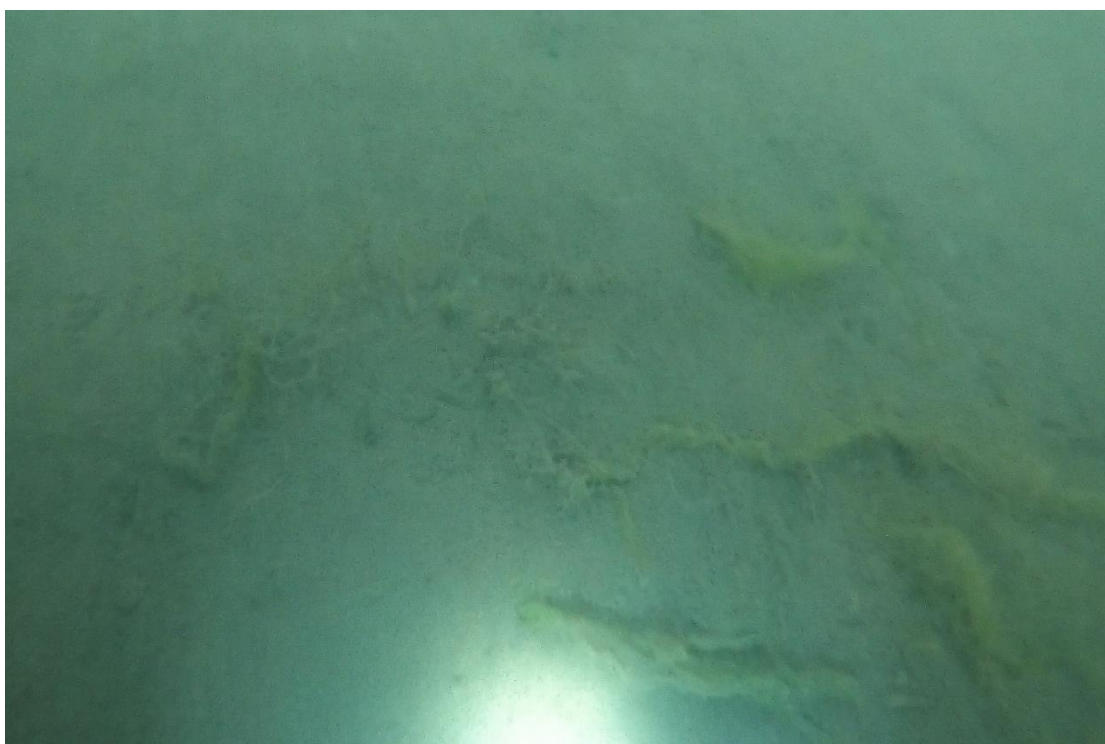
The duration of the video transect at station 5 was approximately 2.5 minutes long. The depth recorded at this station was less than 0.5m below chart datum. The substrate again consisted of thick soft mud. The large patches of benthic diatoms recorded at other stations was not observed along this transect. However, the visibility was poor due to the shallow depth at this station resulting in slight disturbance of the surface silt as the boat transited. Again, while the surface seemed oxygenated, subsurface anoxic sediment was visible immediately below. A shore crab (*Carcinus maenus*) was recorded but little evidence of other fauna was observed. Some drift and decaying algae were observed which was possibly *Enteromorpha/Ulva* spp. but was difficult to discern due to the poor visibility.

Figure 3-25: Lough Atalia Station 5.1. Soft mud with an oxygenated appearance

Figure 3-26: Lough Atalia Station 5.2. Soft mud with an oxygenated appearance.

Figure 3-27: Lough Atalia Station 5.3 Shore crab *Carcinus maenus*.

Figure 3-28: Lough Atalia Station 5.3. Drift and decaying algae, possibly *Enteromorpha/Ulva*.

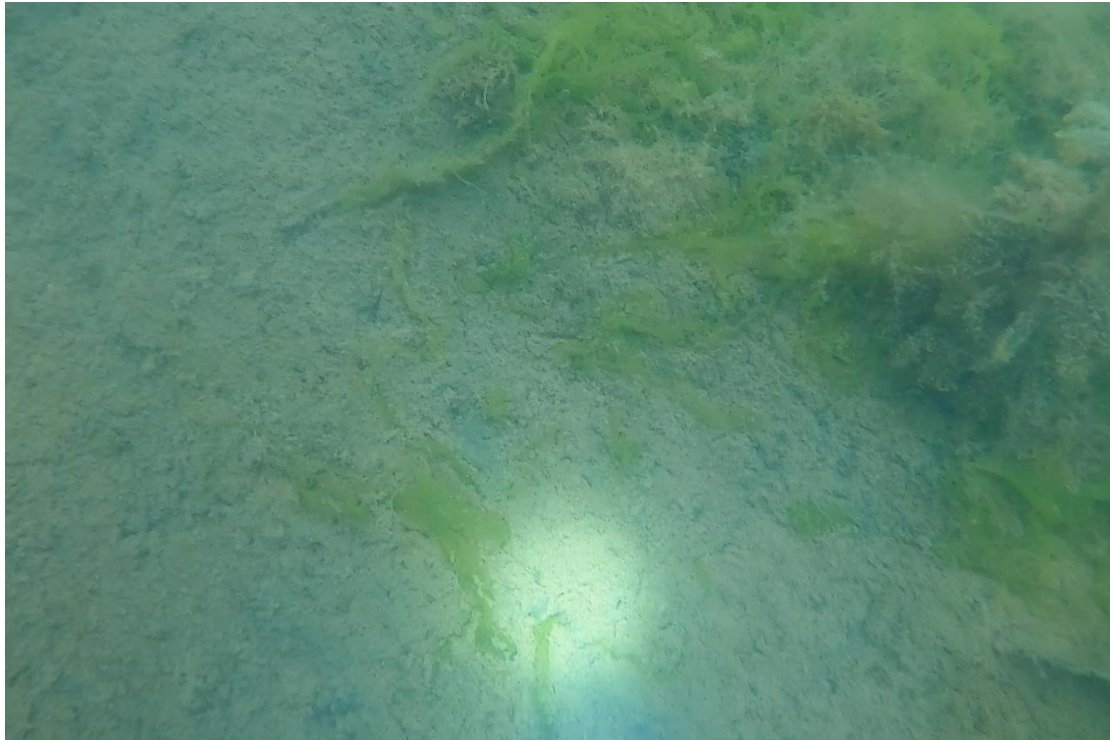
The duration of the video transect at station 6 was approximately 2 minutes long. The depth recorded at this station was less than 0.5m below chart datum. The substrate consisted of thick mud with a patches of benthic diatoms on the surface. The sediment surface along this transect appeared less oxygenated than at previous stations with larger areas of surface anoxic sediment. *Beggiatoa* mats were also observed. The only fauna recorded at this station were a shore crab and a goby. Tracks of both these taxa can be seen across the surface of the mud can be seen along the transect, with the smaller disturbance from crab movement and larger areas disturbed by the fish. Some drift and decaying algae were observed including *Enteromorpha/Ulva* spp and *Chaetomorpha linum*.

Figure 3-29: Lough Atalia Station 6.1. Soft mud with tracks of mobile surface fauna.

Figure 3-30: Lough Atalia Station 6.2. Soft mud with a large patch of anoxic surface sediment.

Figure 3-31: Lough Atalia Station 6.3 Soft mud with benthic diatoms, *Carcinus maenus*, and tracks of mobile surface fauna.

Figure 3-32: Lough Atalia Station 6.4 Patch of drift and decaying algae including *Enteromorpha/Ulva*.

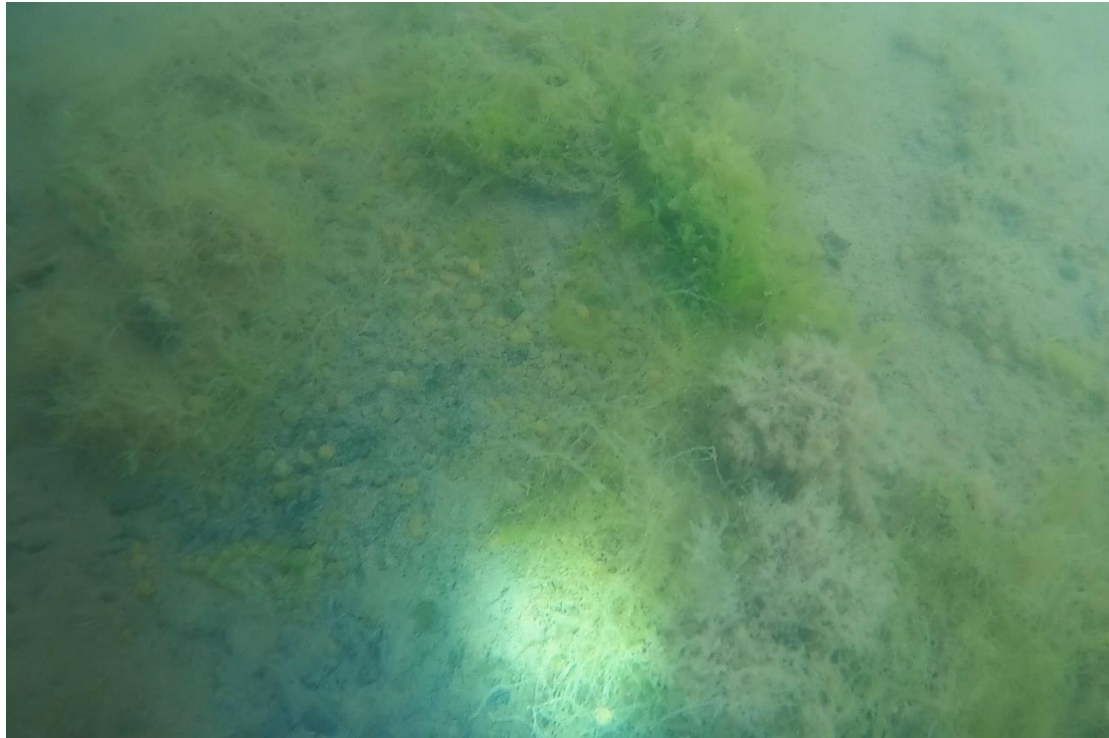
The duration of the video transect at station 8 was approximately 2 minutes long. The depth recorded at this station was less than 0.5m below chart datum. The substrate as in the majority of the stations consisted of thick mud. While the surface for the most part seemed oxygenated, it was apparent wherever the surface was disturbed that anoxic sediment was immediately below. The surface along the transect had several large patches of drift and decaying algae including *Entreomorpha/Ulva* and possibly *Chaetomorpha linum* and *Cladophora* spp. Tracks of mobile surface fauna are visible as well as a shore crab and two gobies.

Figure 3-37: Lough Atalia Station 8.1. Soft mud sediment with an oxygenated appearance.

Figure 3-38: Lough Atalia Station 8.2. Patches of drift and decaying algae with anoxic sediment.

Figure 3-39: Lough Atalia Station 8.3 Shore crab.

Figure 3-40: Lough Atalia Station 8.4. Tracks of mobile surface fauna and disturbed anoxic sediment.
