Lagoon Benthic Surveys,

Lough Atalia & Renmore Lough, Galway

Updated Report

Produced by: AQUAFACT – APEM Group

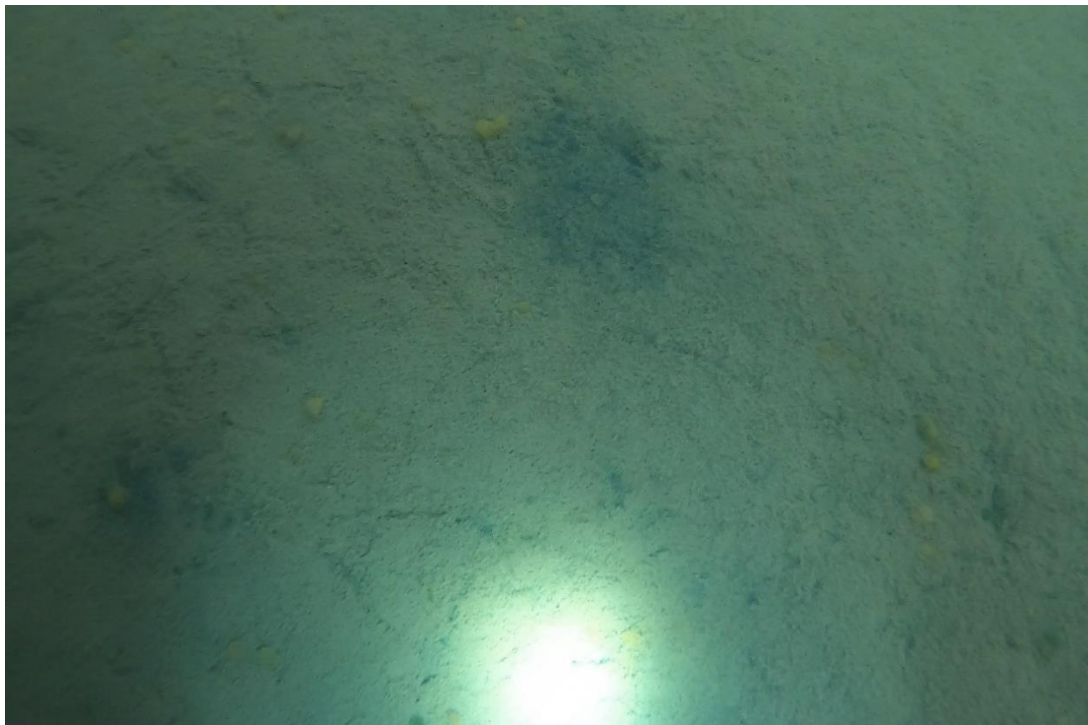
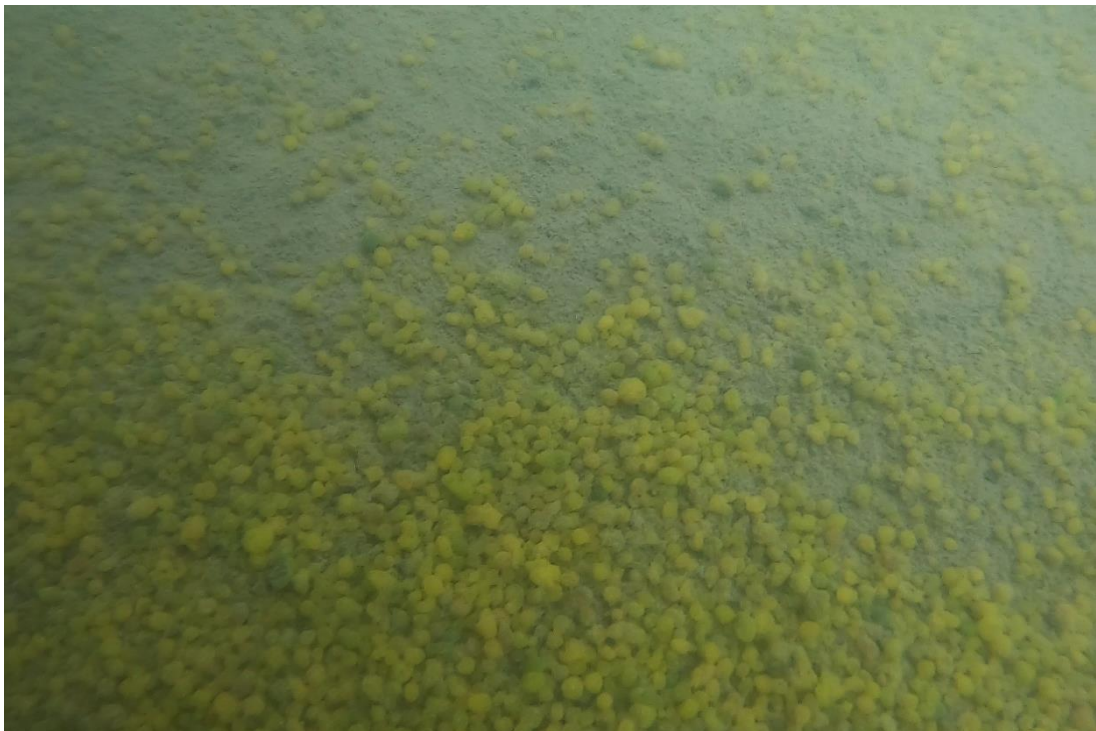
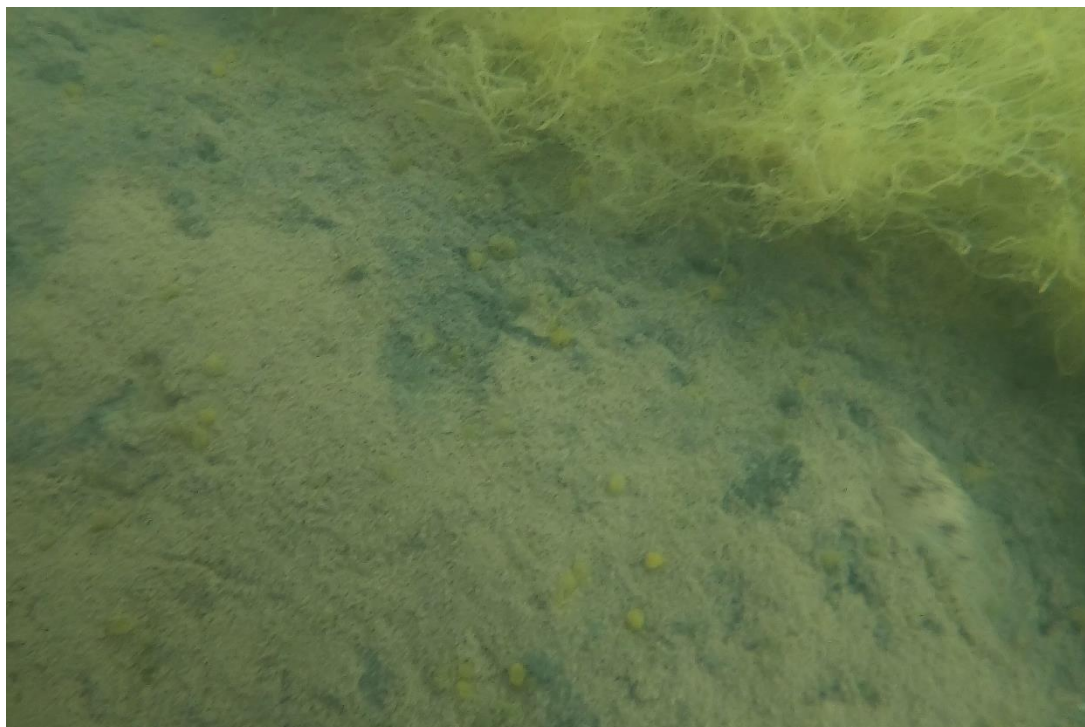
The duration of the video transect at station 9 was approximately 2 minutes long. The depth recorded at this station was less than 0.5m below chart datum. The substrate consisted of thick soft mud. While the surface for the most part seemed oxygenated, it was apparent wherever the surface was disturbed that anoxic sediment was immediately below. This is as a result of the high organic enrichment throughout Lough Atalia. Fauna recorded at this station included two gobies and the shrimp *Crangon* spp. Additionally, evidence of the movements of mobile surface fauna in the area can be seen in tracks across the surface of the mud. Small green jelly like balls which appear to be algae-like but were unable to be identified from the footage are noted to be present on top of the surface at this station which can be clearly observed in **Figure 3-44** Some drift and decaying algae were observed including *Enteromorpha/Ulva* spp and *Chaetomorpha linum*.

Figure 3-41: Lough Atalia Station 9.1. Soft mud with anoxic subsurface sediment exposed

Figure 3-42: Lough Atalia Station 9.2. Tracks of mobile surface fauna exposing anoxic subsurface conditions

Figure 3-43: Lough Atalia. Station 9.3. Patch of algae (possibly *Chaetomorpha linum*) on sediment surface. Unidentified ball-like plant matter.

Figure 3-44: Lough Atalia Station 9.4. Large patch of unidentifiable plant matter

Figure 3-45: Lough Atalia Station 9.5. Soft muddy substrate with anoxic subsurface conditions. Patch of algae present (*Chaetomorpha linum*).

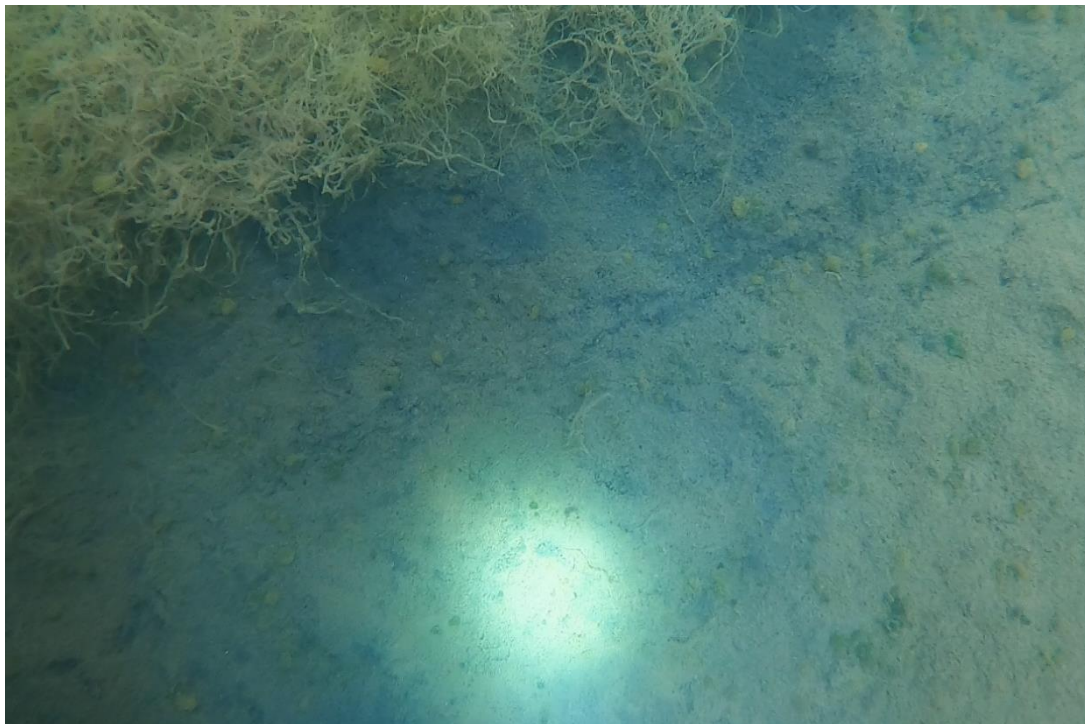
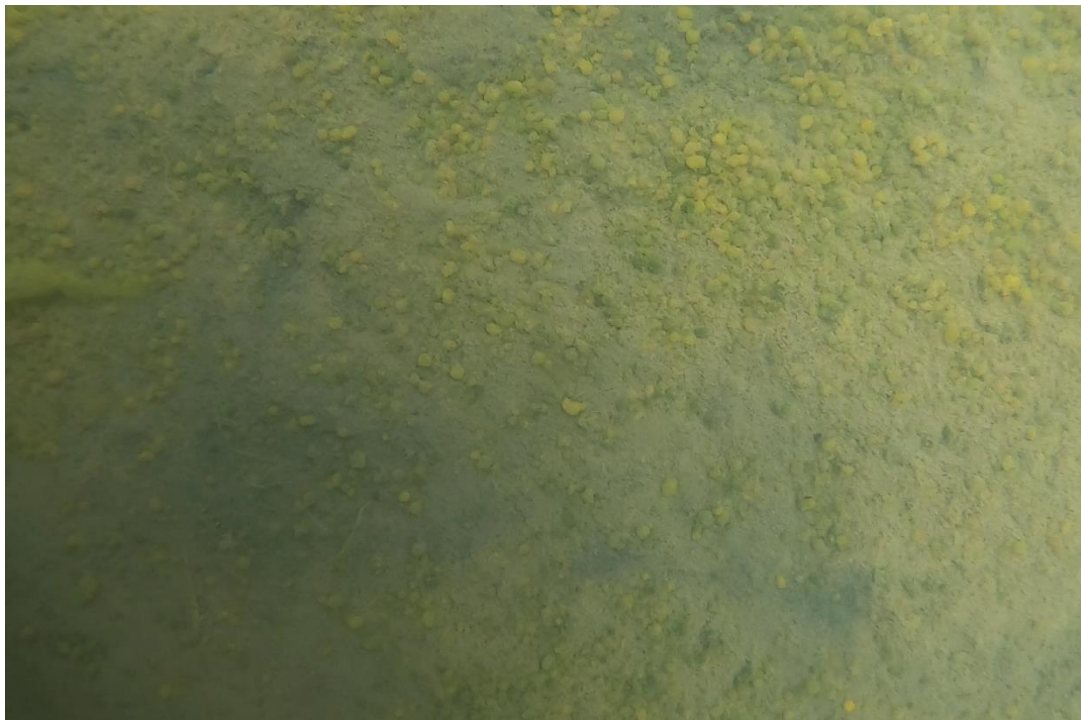
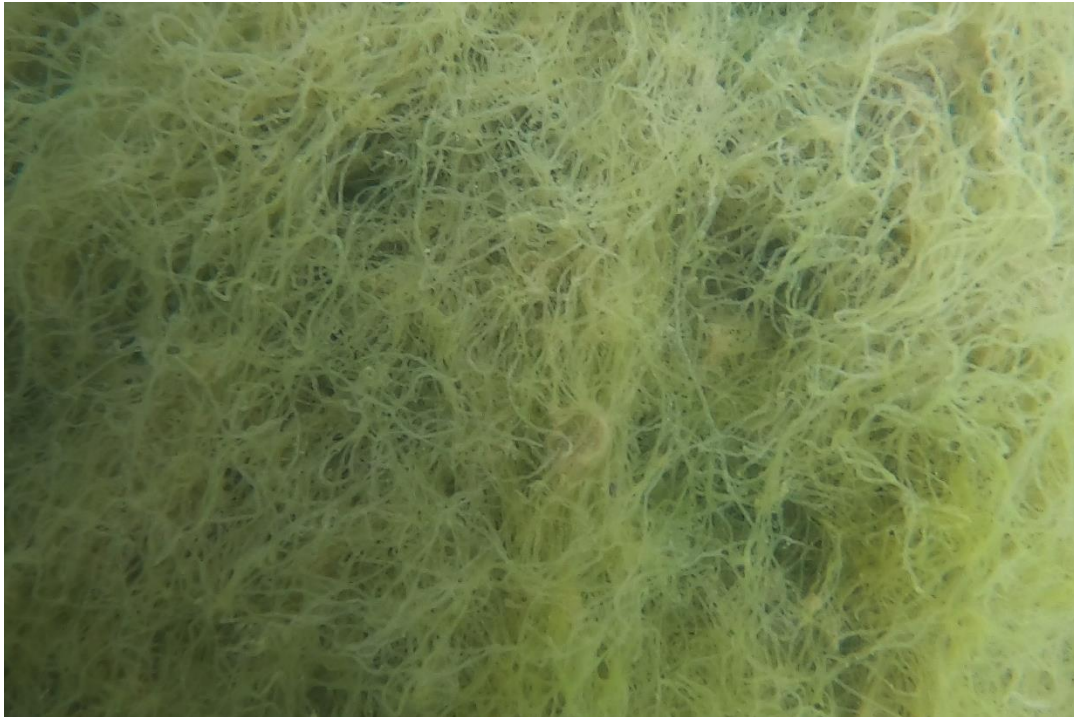
The duration of the transect at station 10 was approximately 1.5 minutes long. The depth recorded at this station was less than 0.5m below chart datum. The substrate consisted of thick mud. While the surface for the most part seemed oxygenated, it was apparent wherever the surface was disturbed that anoxic sediment was immediately below. There was also a small patch of *Beggiatoa* observed. This is as a result of the high organic enrichment throughout Lough Atalia. No fauna was recorded at this station on the DDV however evidence of the movements of crabs in the area can be seen in tracks across the surface of the mud. The same small green nodules observed in station 9, which appear to be algal like but were unable to be identified from the footage, are noted to be present on top of the surface at this station which can be clearly observed in **Figure 3-49**. Some drift and decaying algae were observed including *Enteromorpha/Ulva* spp and *Chaetomorpha linum*.

Figure 3-46: Lough Atalia Station 10.1 Soft mud with an oxygenated appearance.

Figure 3-47: Lough Atalia Station 10.2 Patch of decaying algae and exposed anoxic sediment.

Figure 3-48: Lough Atalia Station 10.3. Tracks of mobile surface fauna.

Figure 3-49: Lough Atalia Station 10.4. Unidentified green algal-like structures. Anoxic sediment.

Figure 3-50: Lough Atalia Station 10.5 Close up of a patch of drift algae (*Chaetomorpha linum*).

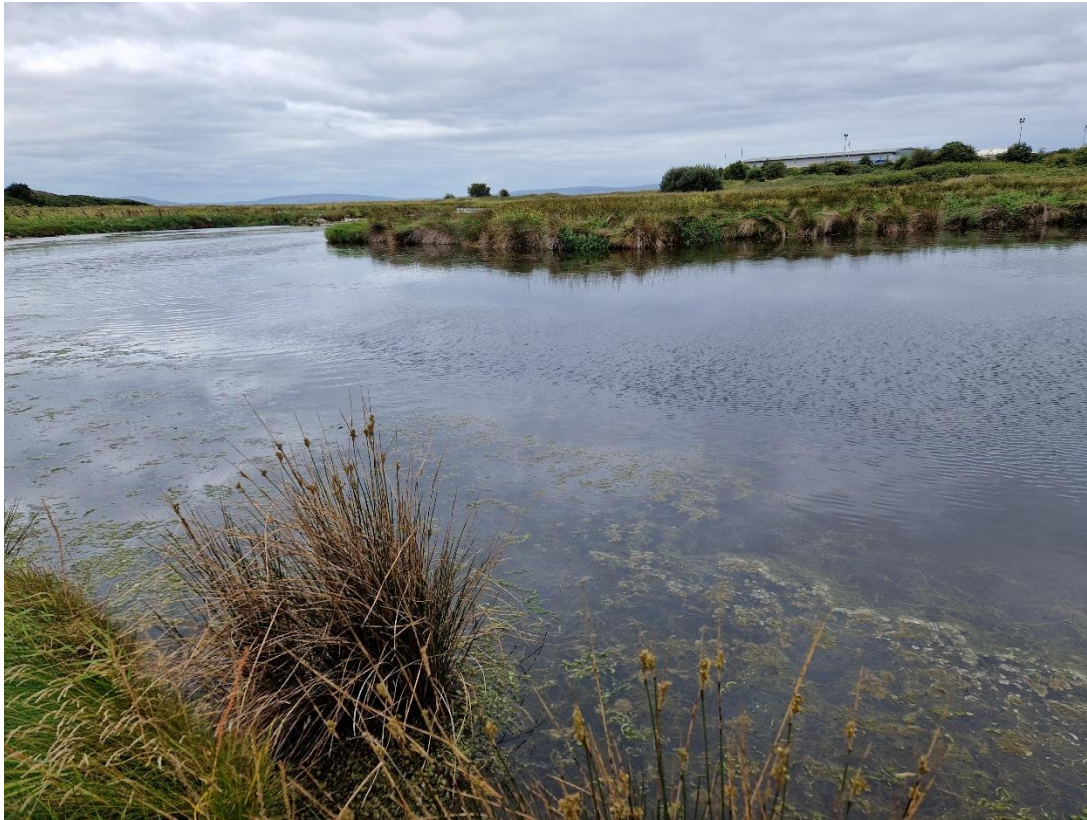
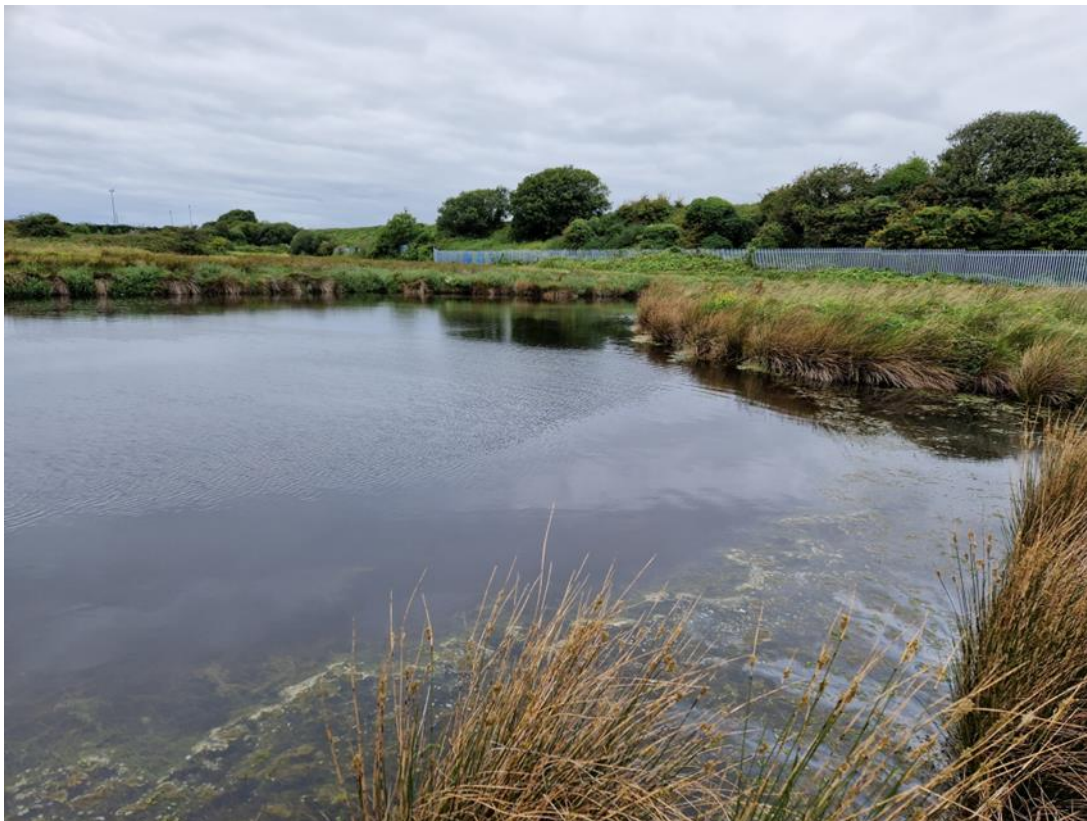
The sweep survey was carried out at 2 stations (see **Figure 3-51**, **Figure 3-52**) and showed a similar composition of lagoonal specialist species as those observed in a previous monitoring survey in 2016 carried out by AQUAFACT for the National Parks and Wildlife Services (NPWS) and the Environmental Protection Agency (EPA) as part of the 'Coastal Lagoon Monitoring Programme 2016-2017' (Roche *et al.*, 2017) and shared some similarities with the benthic survey for the original EIS.

During the sweep survey a strong odour of hydrogen sulphide was noted at survey stations, indicating anoxic conditions in the sediment of the lagoon.

Figure 3-51: Station 1 at Renmore Lough.

Figure 3-52: Station 2 at Renmore Lough.
