**RE: PA0033 - Galway Harbour Extension – Renmore and Townparks Townland, Galway
Compensatory Measures Proposal
Response to An Bord Pleanála letter of 20 October 2021**

Response to An Bord Pleanála arising from National Parks and Wildlife Service Queries on Compensatory Measures Plan

Client:	Galway Harbour Company
Project:	Galway Harbour Extension
Title:	Response to An Bord Pleanála arising from National Parks and Wildlife Service Queries on Compensatory Measures Plan

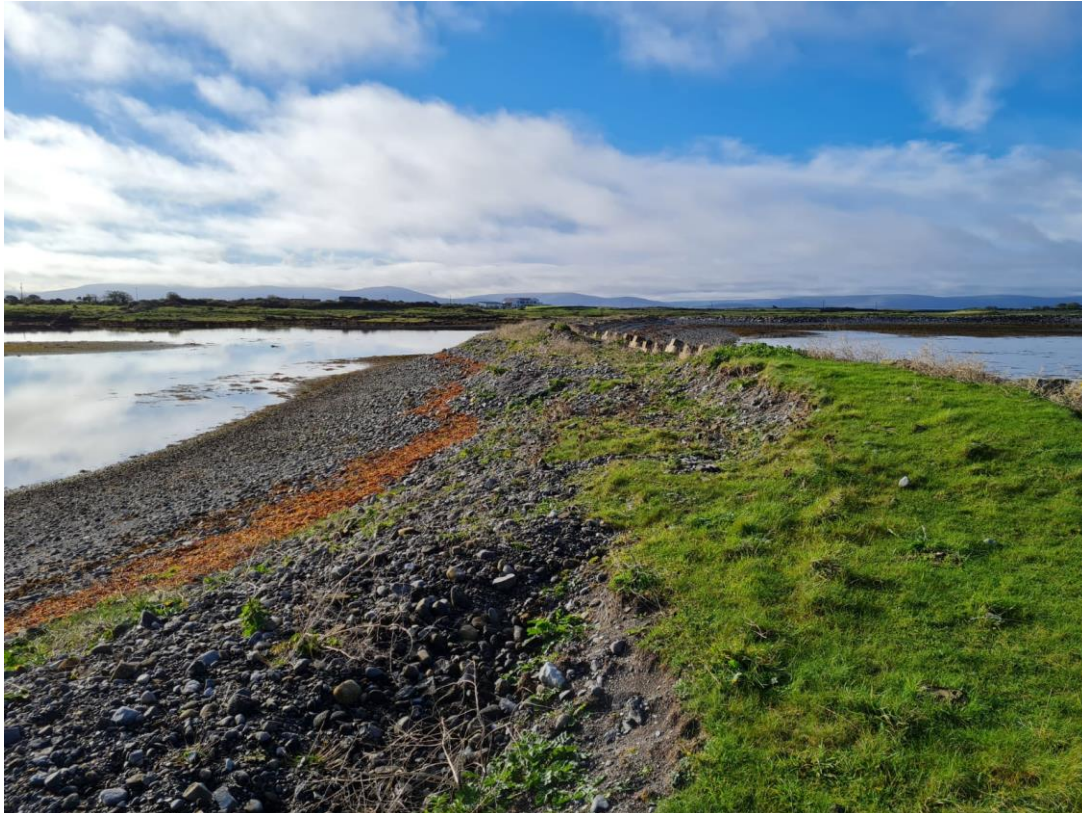
Figure 7-2: Erosion behind sea defence blocks, Lurgan Island, October 2021.

The recent surveys and studies on the toe, the angle of the blocks and the crest are showing significant slippage of the top lines of concrete blocks which were constructed as part of the existing sea defences.

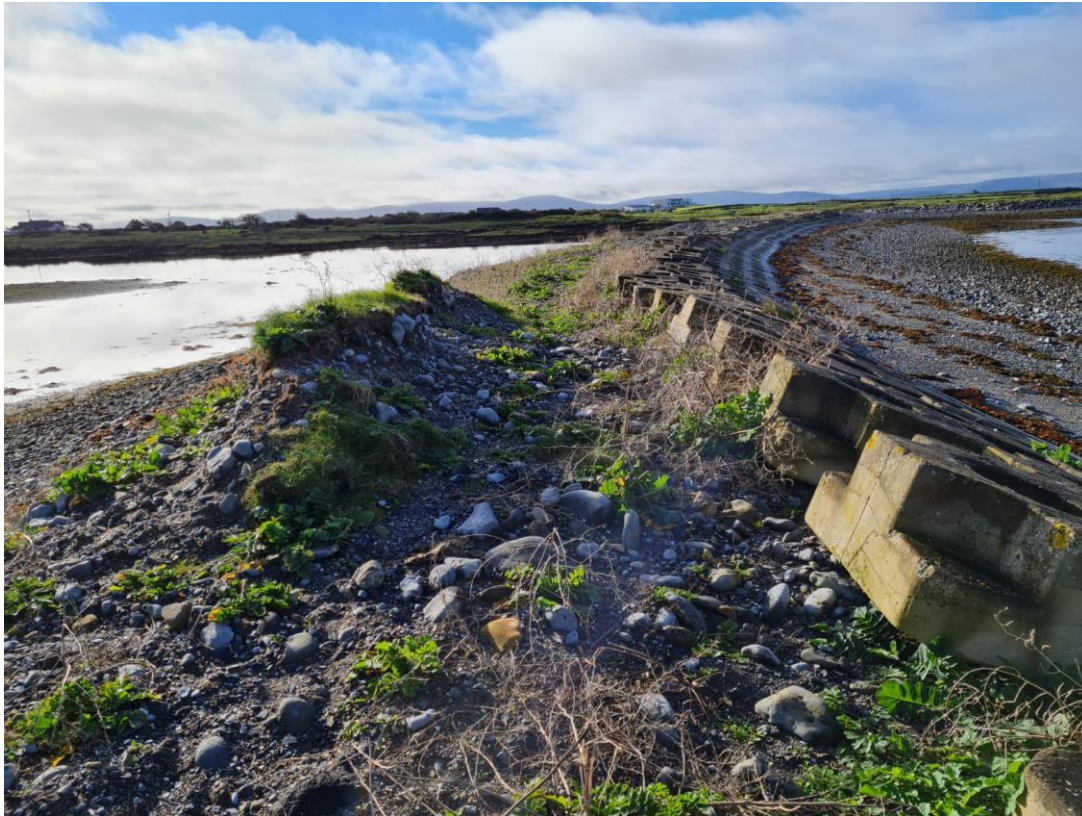
Figure 7-3: Destabilisation of sea defence blocks, Lurgan Island, October 2021.

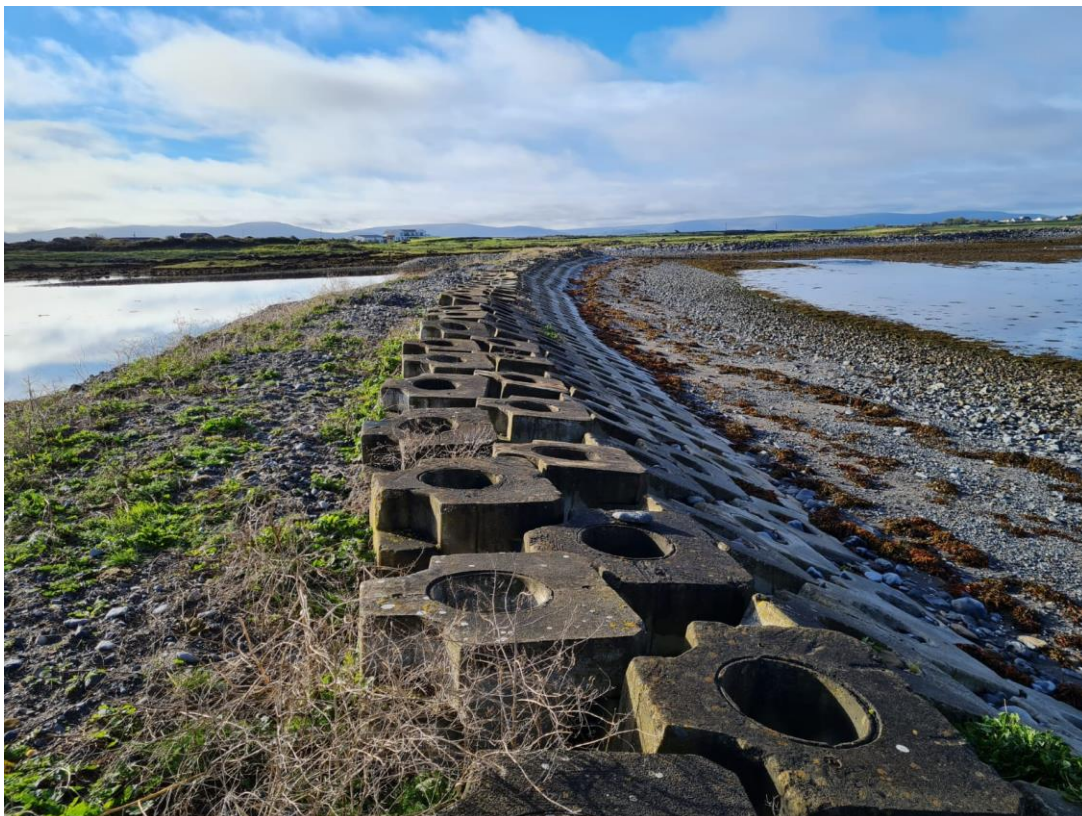
Figure 7-4: Flattening out of top layer of sea defence blocks, Lurgan Island, October 2021.

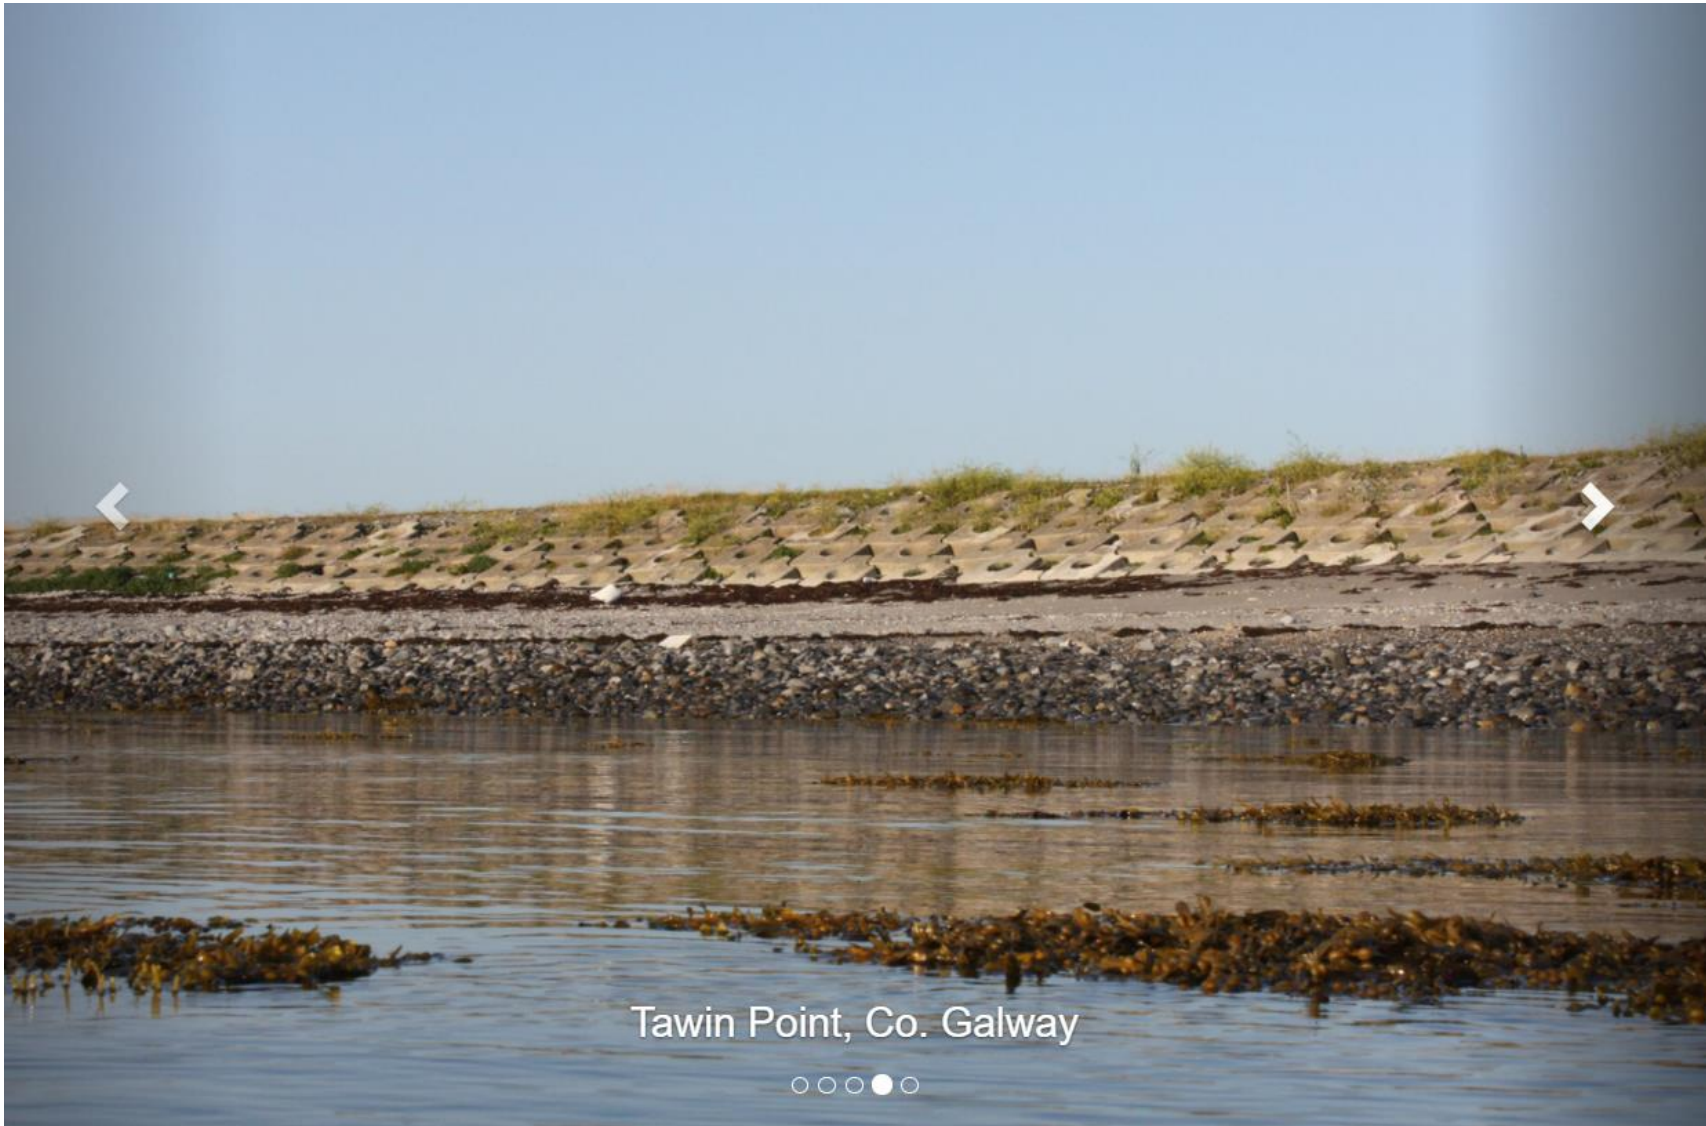
Plate 2. View of interlocking concrete block revetment at Lurgan Island (extract from ECPS Ltd. Ecab.ie).

The ECAB is octagonal in shape and has recesses and projections on opposite sides of the unit to allow adjacent blocks to interlock. The blocks are placed in a honeycomb pattern at a slope of 1 in 2 or flatter. An underling filter material is often required to prevent wash out through the voids in the unit. In the case of Lurgan, the coarse shingle from the beach was used as the filter layer. The units and placement pattern provides almost 40% porosity that assists in dissipation of wave energy and reduction in wave reflection coefficient to between 0.2 and 0.5 based on physical model tests. Expected wave run-up is 3 to 1 (*i.e.* 3m runup for a 1m wave height). It is understood that the Lurgan site was a test site for ECAB. The photo at the end of construction presented in Plate 1 shows that the voids were back filled with the local shingle, to act as "grass blocks" which they initially did, as per Plate 2. The effect of this filling caused the actual porosity available for wave energy dissipation to be reduced. Plate 2 taken a number of years later shows, at the lower levels, that much of the shingle material from the interlocking voids has been removed by wave action.

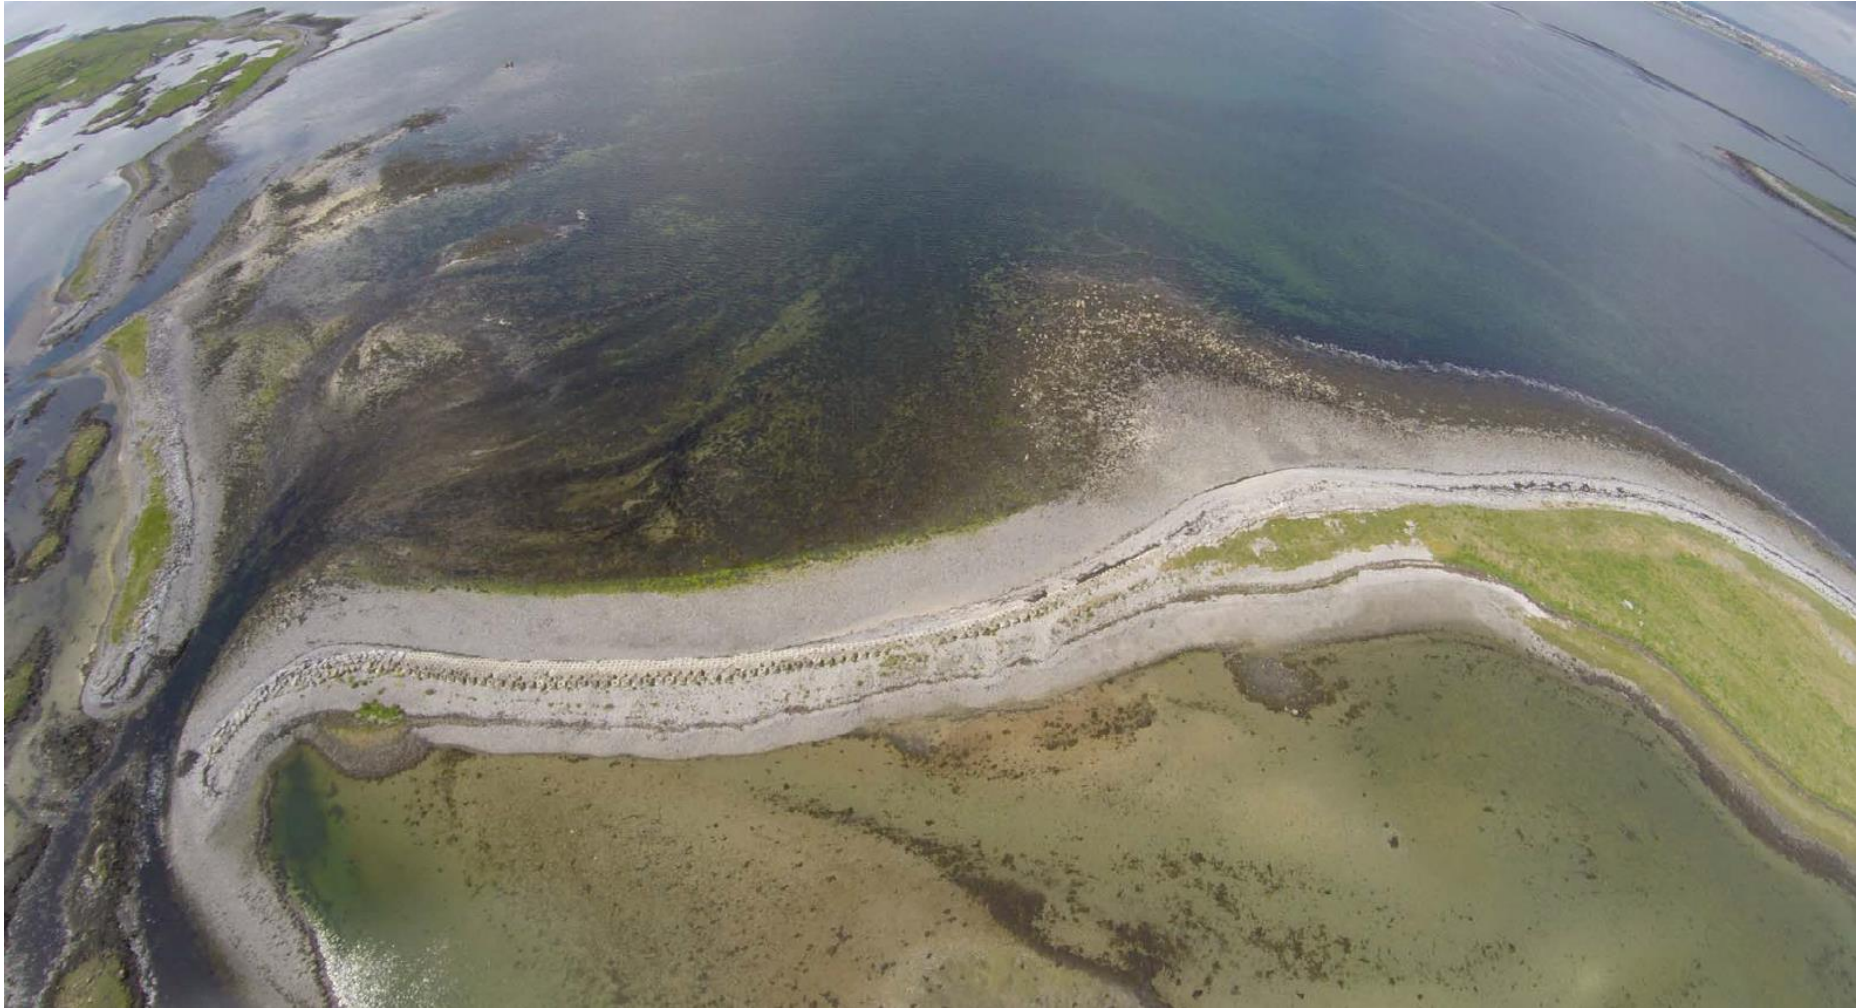
Plate 3. Drone Photo (flown in 2017) of coastal defences and shallow sand intertidal lagoon area behind defences at Lurgan Island

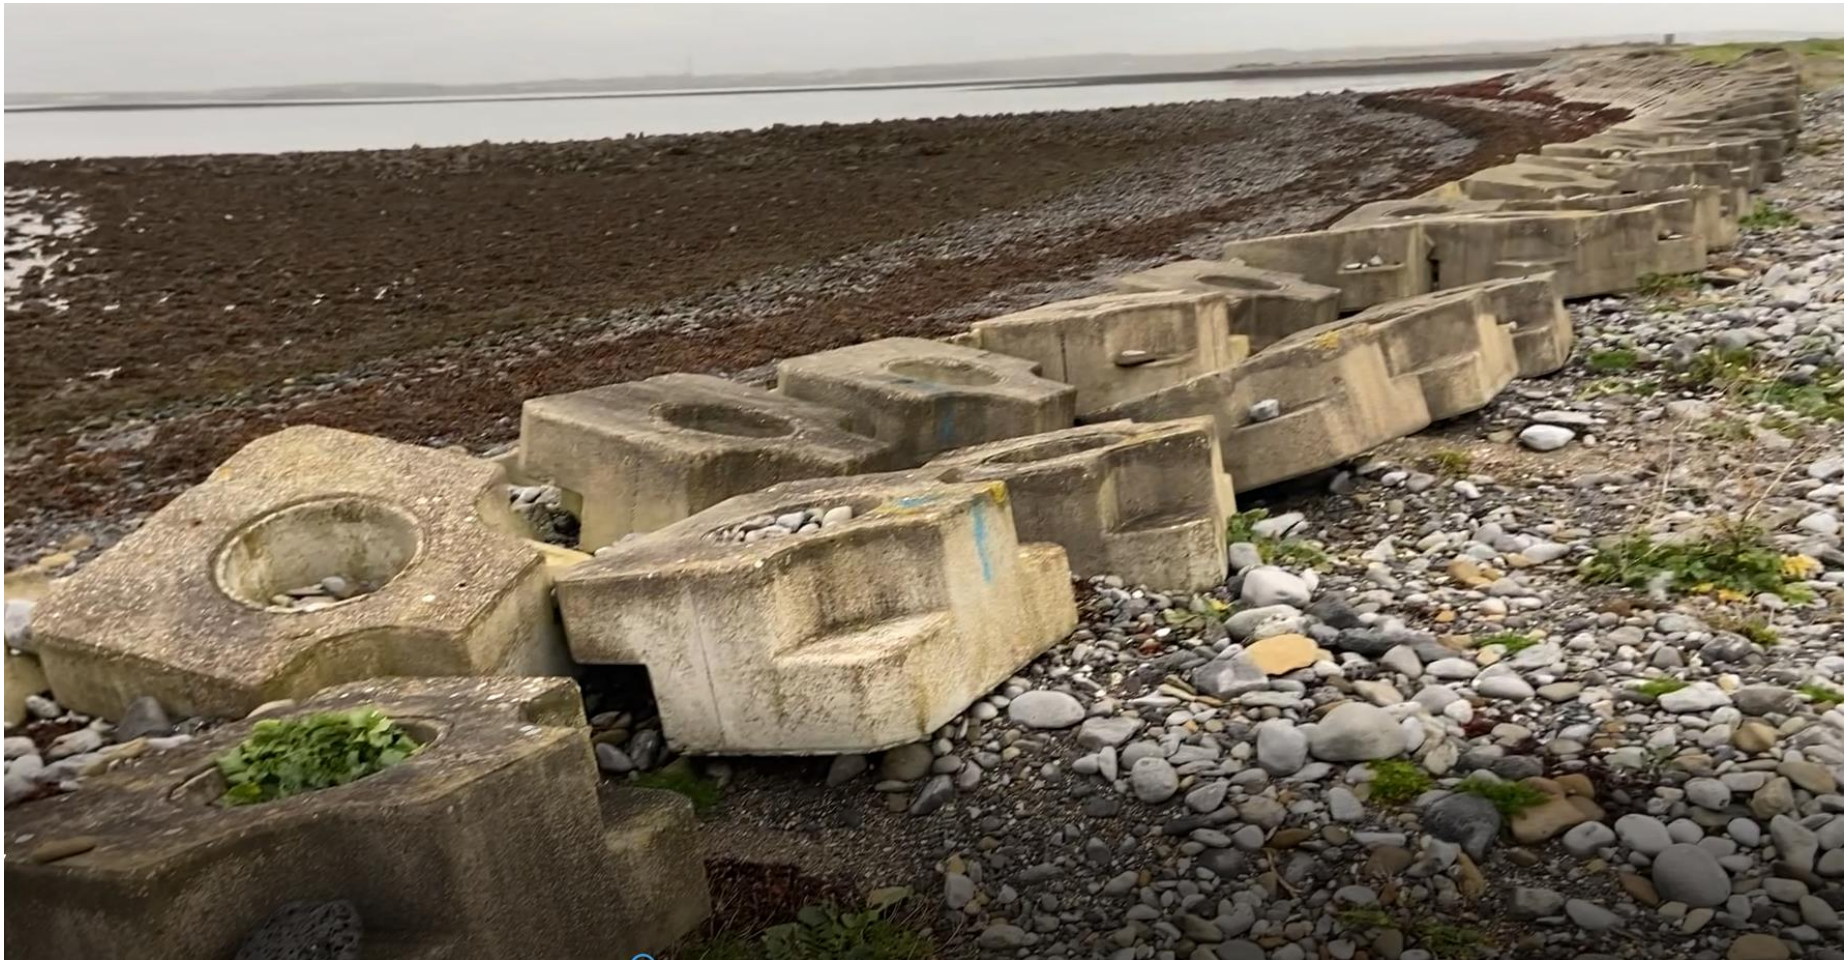
Plate 4. Lowered and displaced section of ECAD revetment at Lurgan Island (November 2021).

The ECAB revetment protection may have worked more successfully as a shoreline defence had a better understanding of the exposure of the site and the elevation of the storm surge highwater level had been acquired. It is considered, based on inspection, that the revetment height was not sufficient to prevent wave run-up and overtopping and, more critically, no top-cap armour block layer and suitably sized capping layer of rip-rap rock armour stone was provided to seal and maintain the interlock matrix, given its location in a moderate to high exposure to the sea waves. The capping material used at the crest of the revetment is generally sand and small cobbles and provides little resistive function once overtopped (refer to Plate 1). This shingle capping has been completely eroded and removed with the ECAB top two block layers completely exposed and many units displaced.

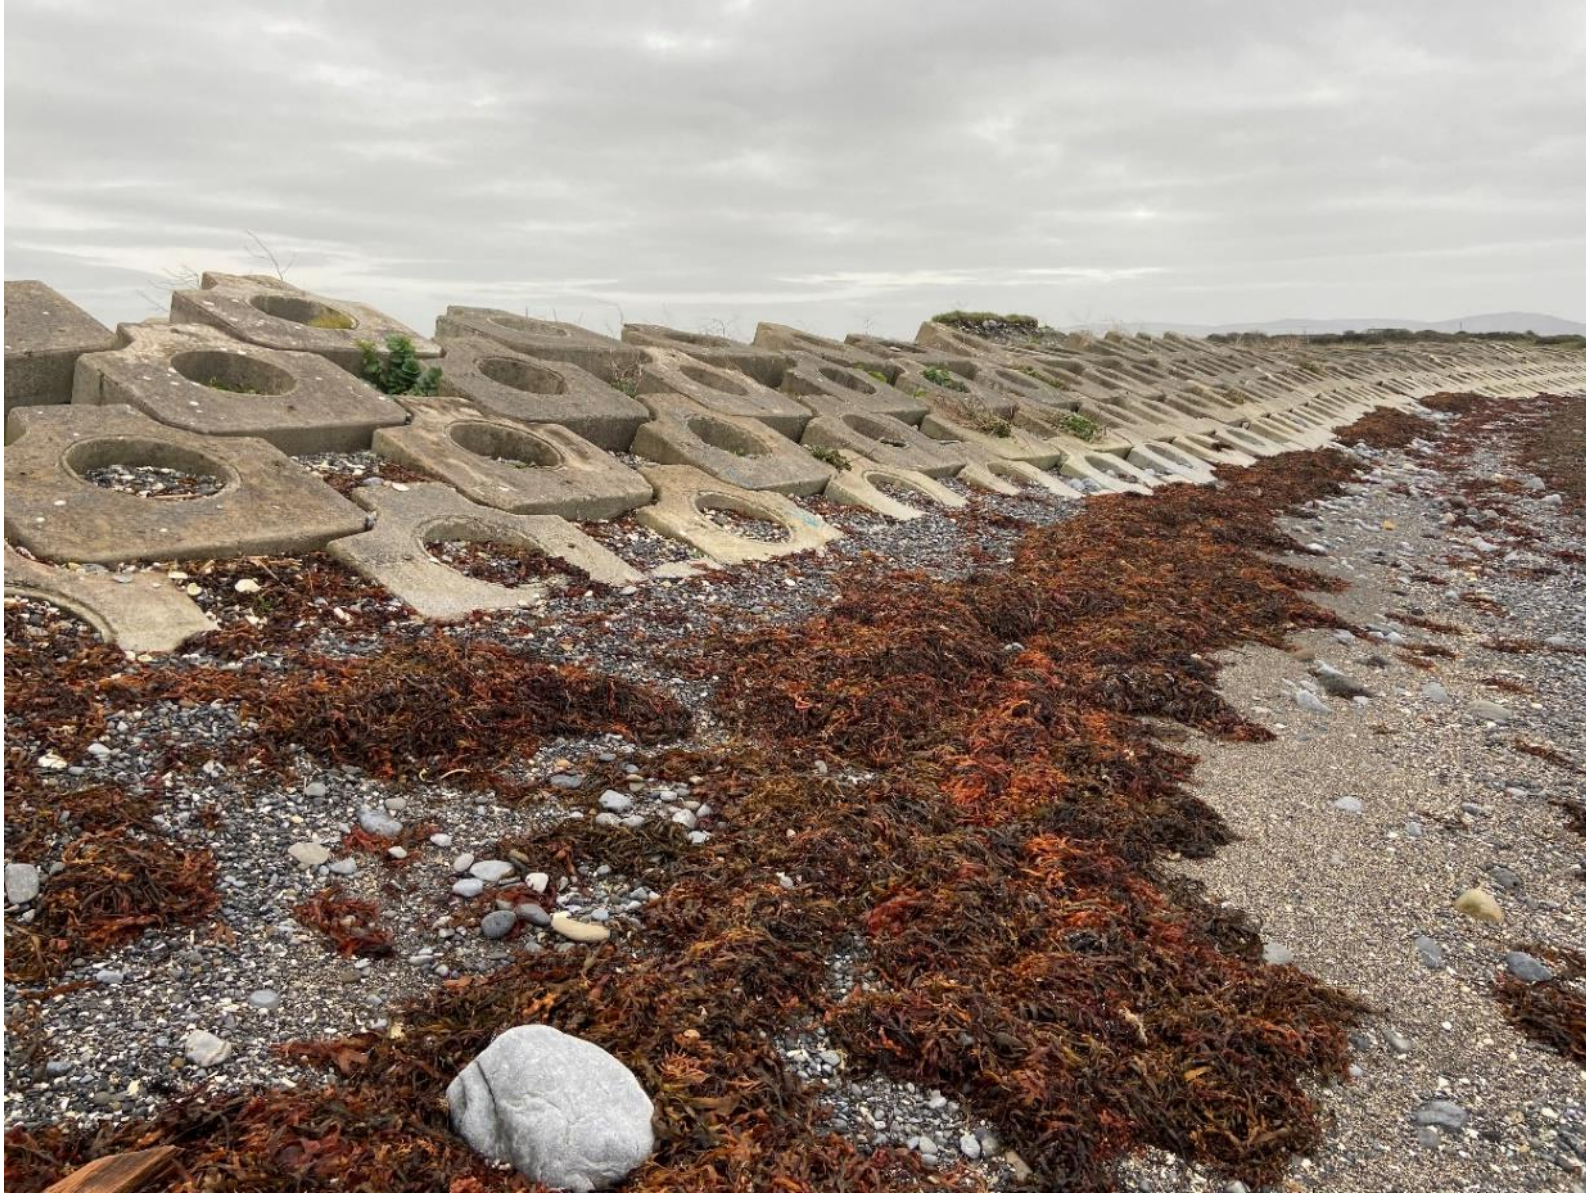
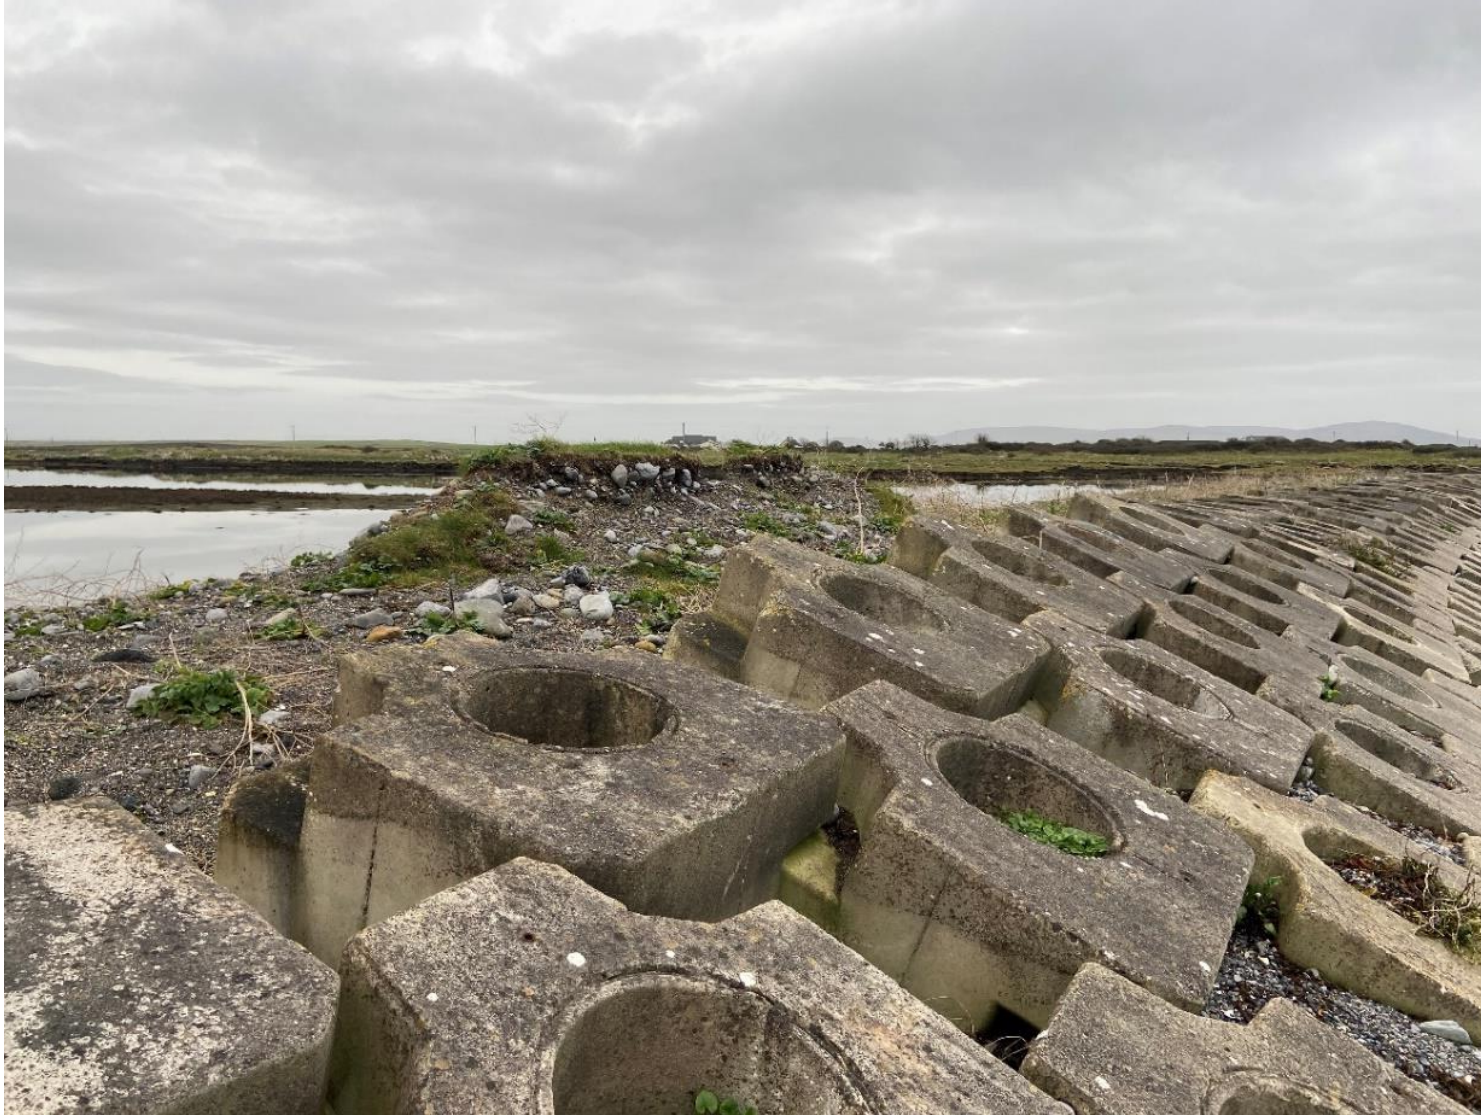
Plate 5. Photos of revetment taken in November 2021 showing substantial undermining of the revetment armour blocks and erosion of the headland behind the defences.

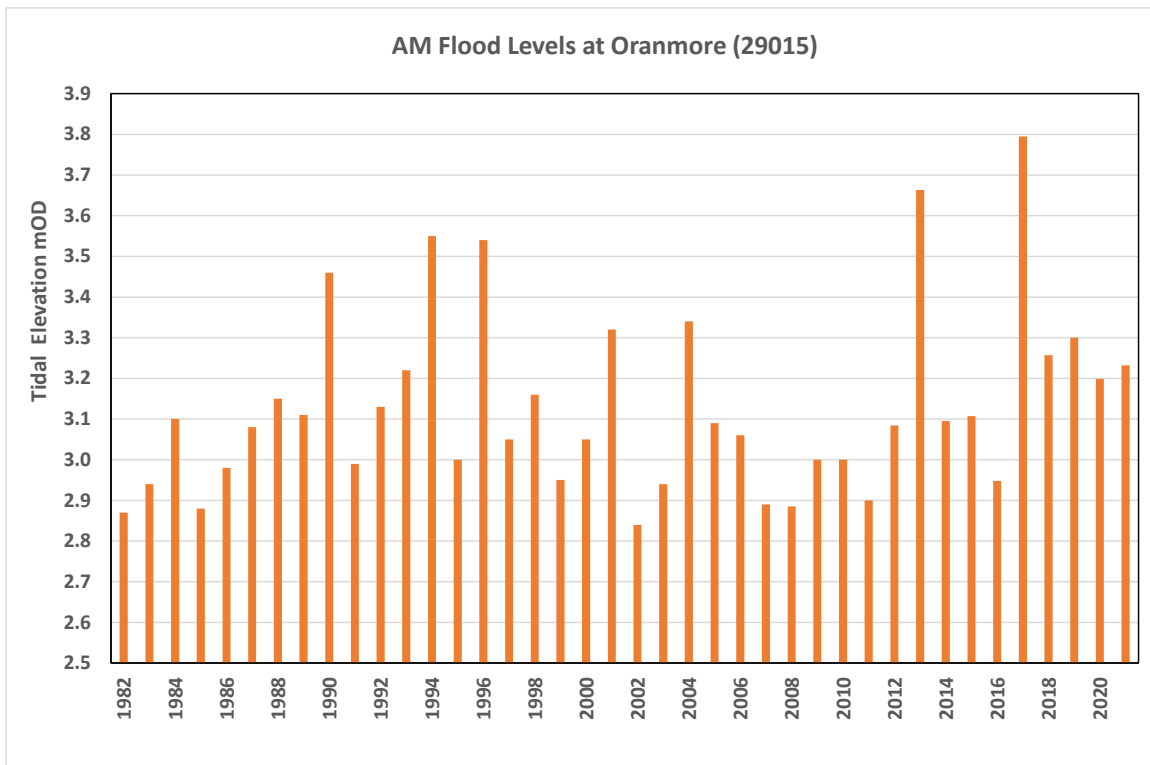
Figure 7-7: Recorded Annual Maximum Flood Level Series at Oranmore Bridge Gauge (20015) from 1982 to 2021

The tidal gauge at Oranmore Bridge (29015) reflects the high tide water levels at Tawin and Mweeloon. The annual maximum highwater series was extracted from the record, refer to **Figure 7-7**. This series shows that 8 annual maximum tidal events out of 40 exceeded 3.3m OD Malin and 5 events exceeded 3.4m OD which represents a still water level at or above the current crest level of the revetment, without any additional wave action. The highest tide reached 3.795m OD on the 2nd of January 2018 and at this level would have completely submerged much of the revetment. Compounding this 2018 coastal event was locally strong westerly winds that locally coincided with the storm surge at the highwater period and consequently would have generated considerable wave attach at the revetment.

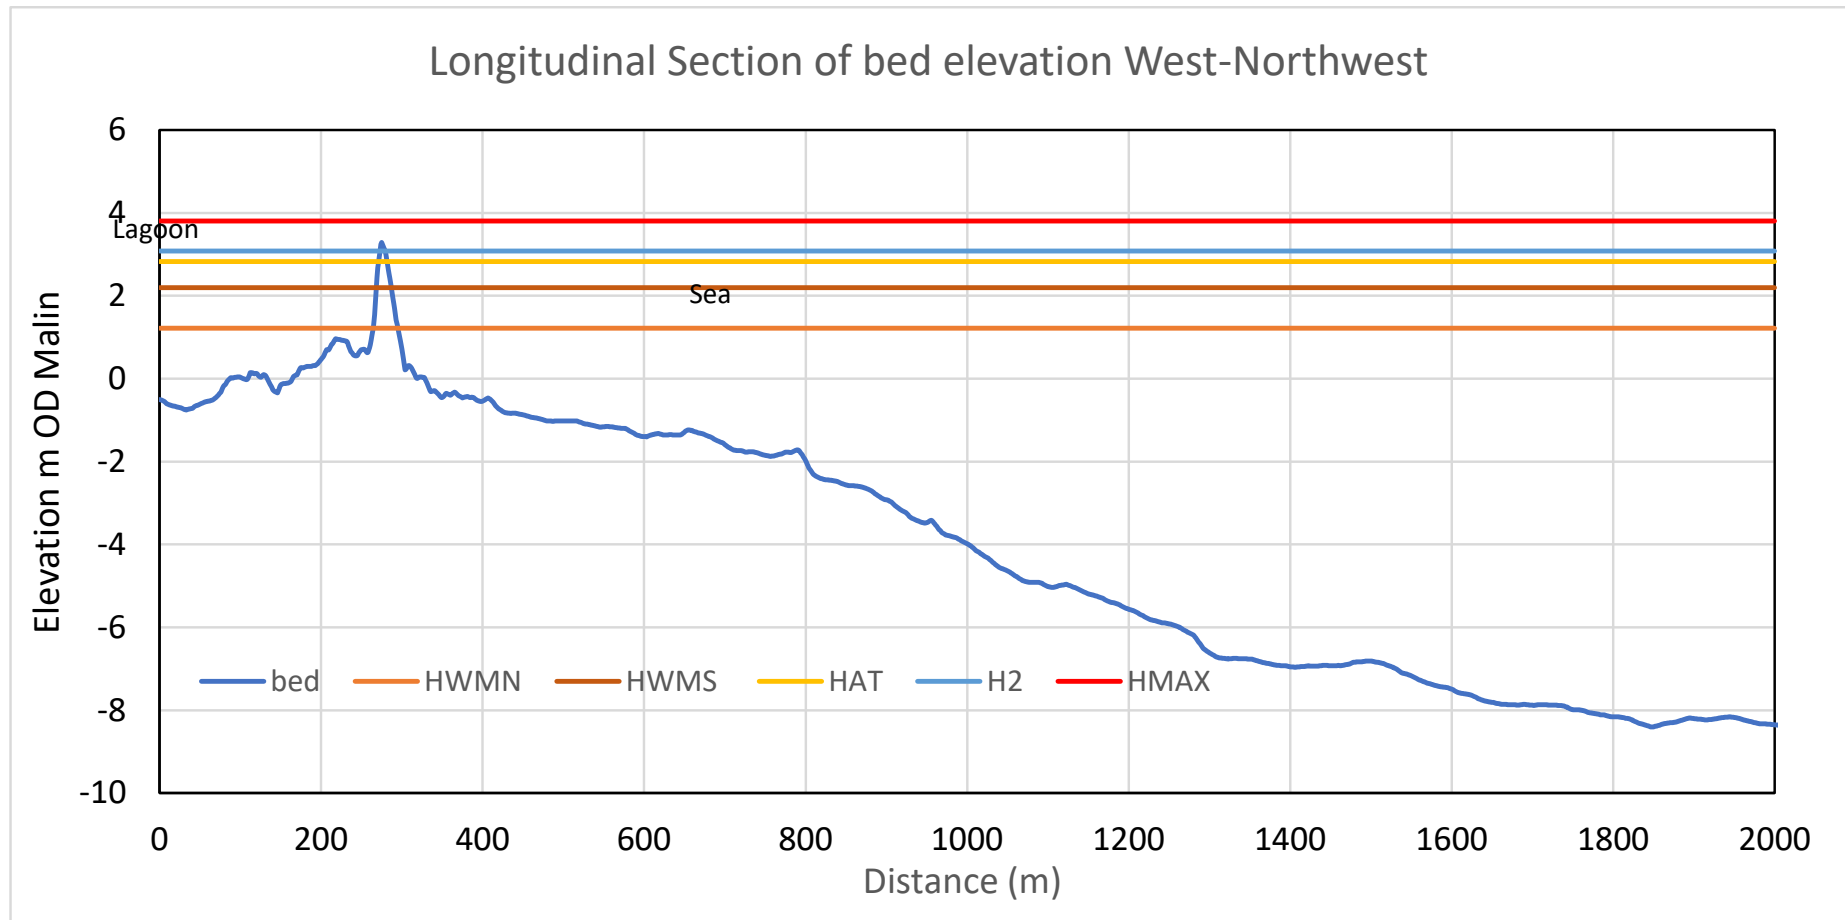
Figure 7-9: Longitudinal Profile A-A from Mweeloon Lagoon Northwest.

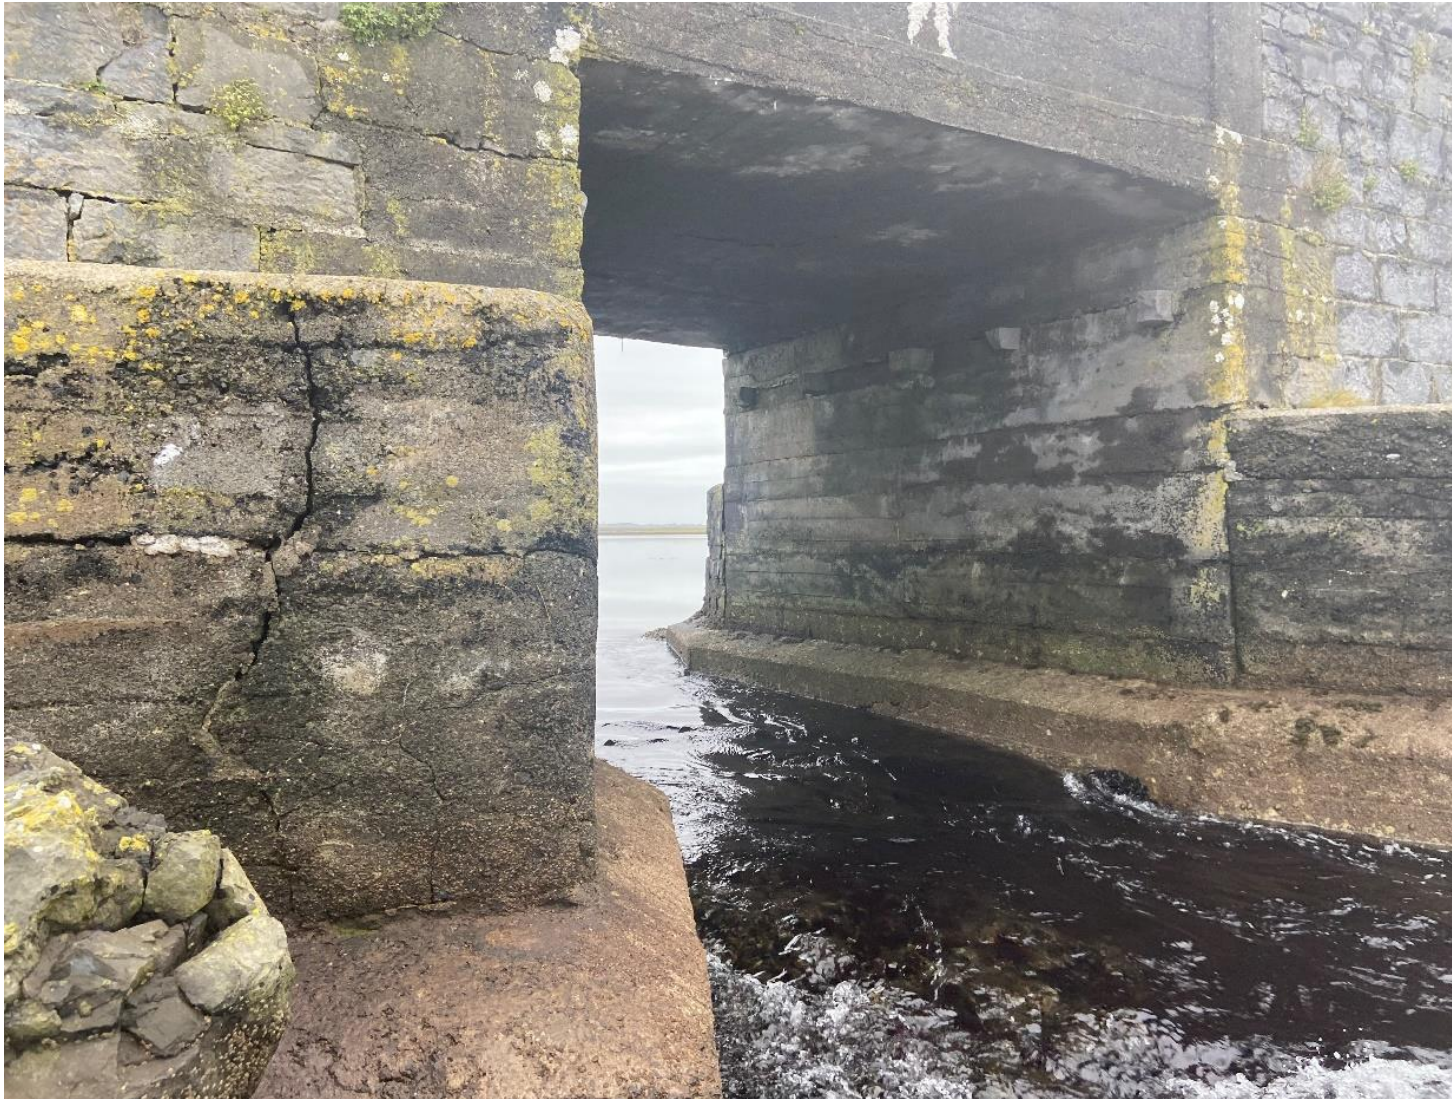
Plate 6 Southern Channel at Ballynacloghy bridge on the Tawin Island local road.

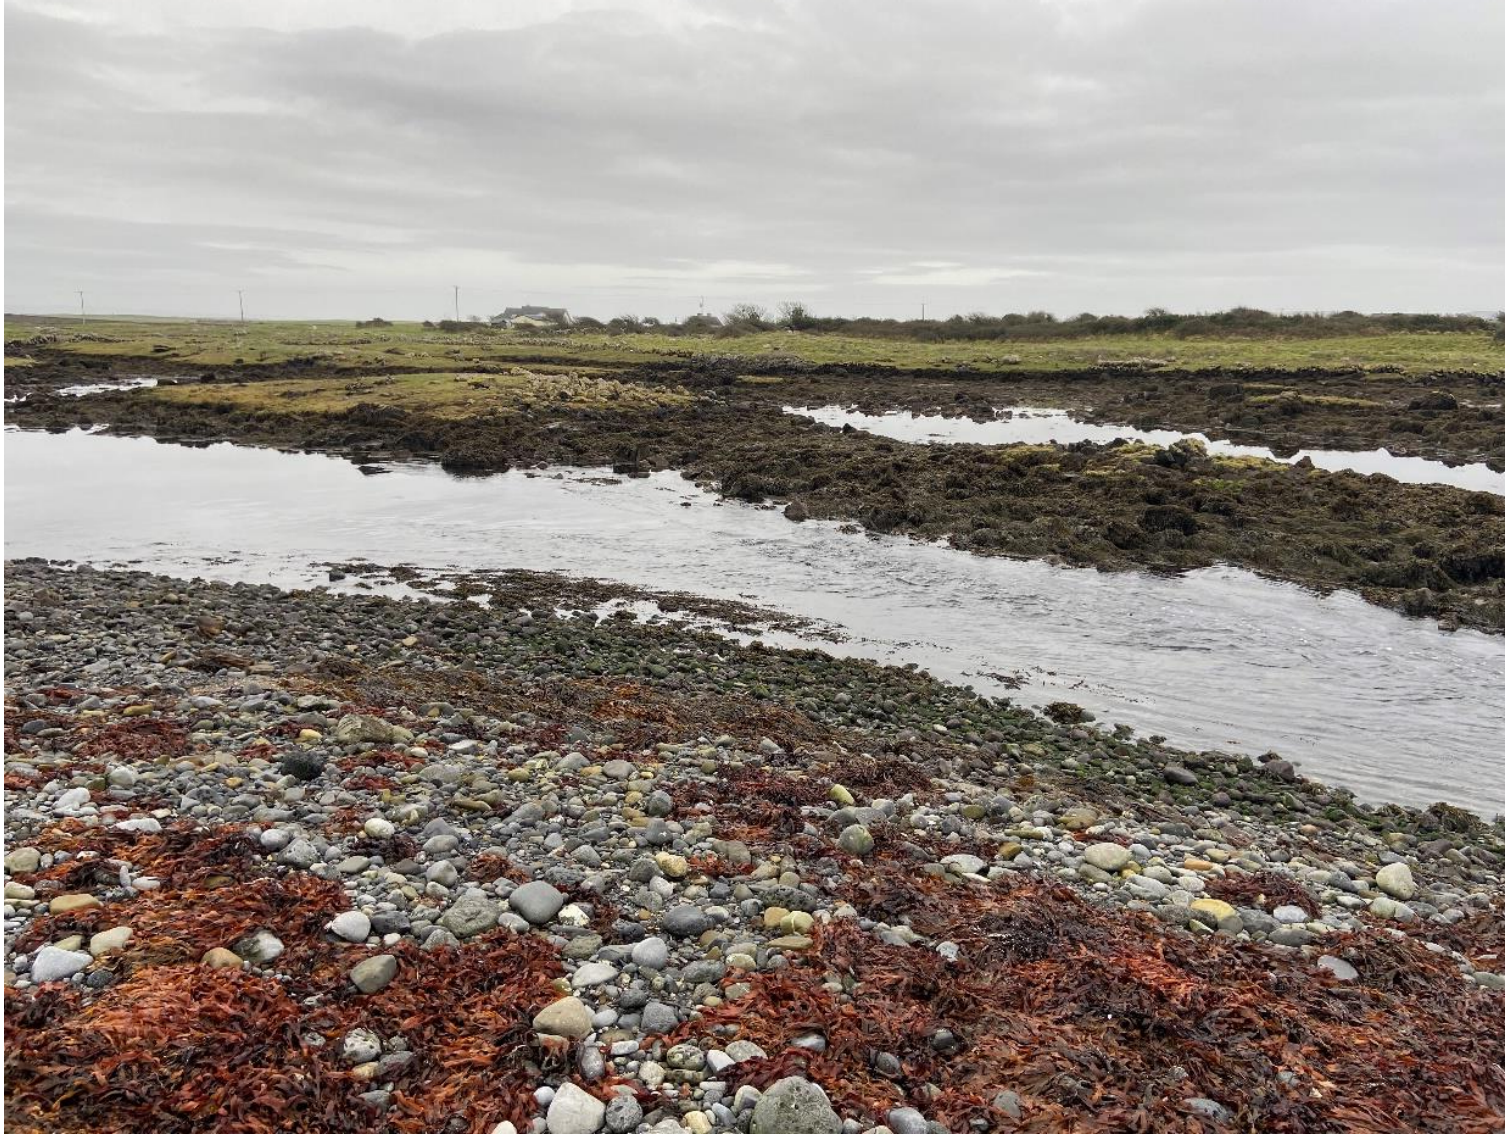
Plate 7. Southwestern Channel at Lurgan Island.

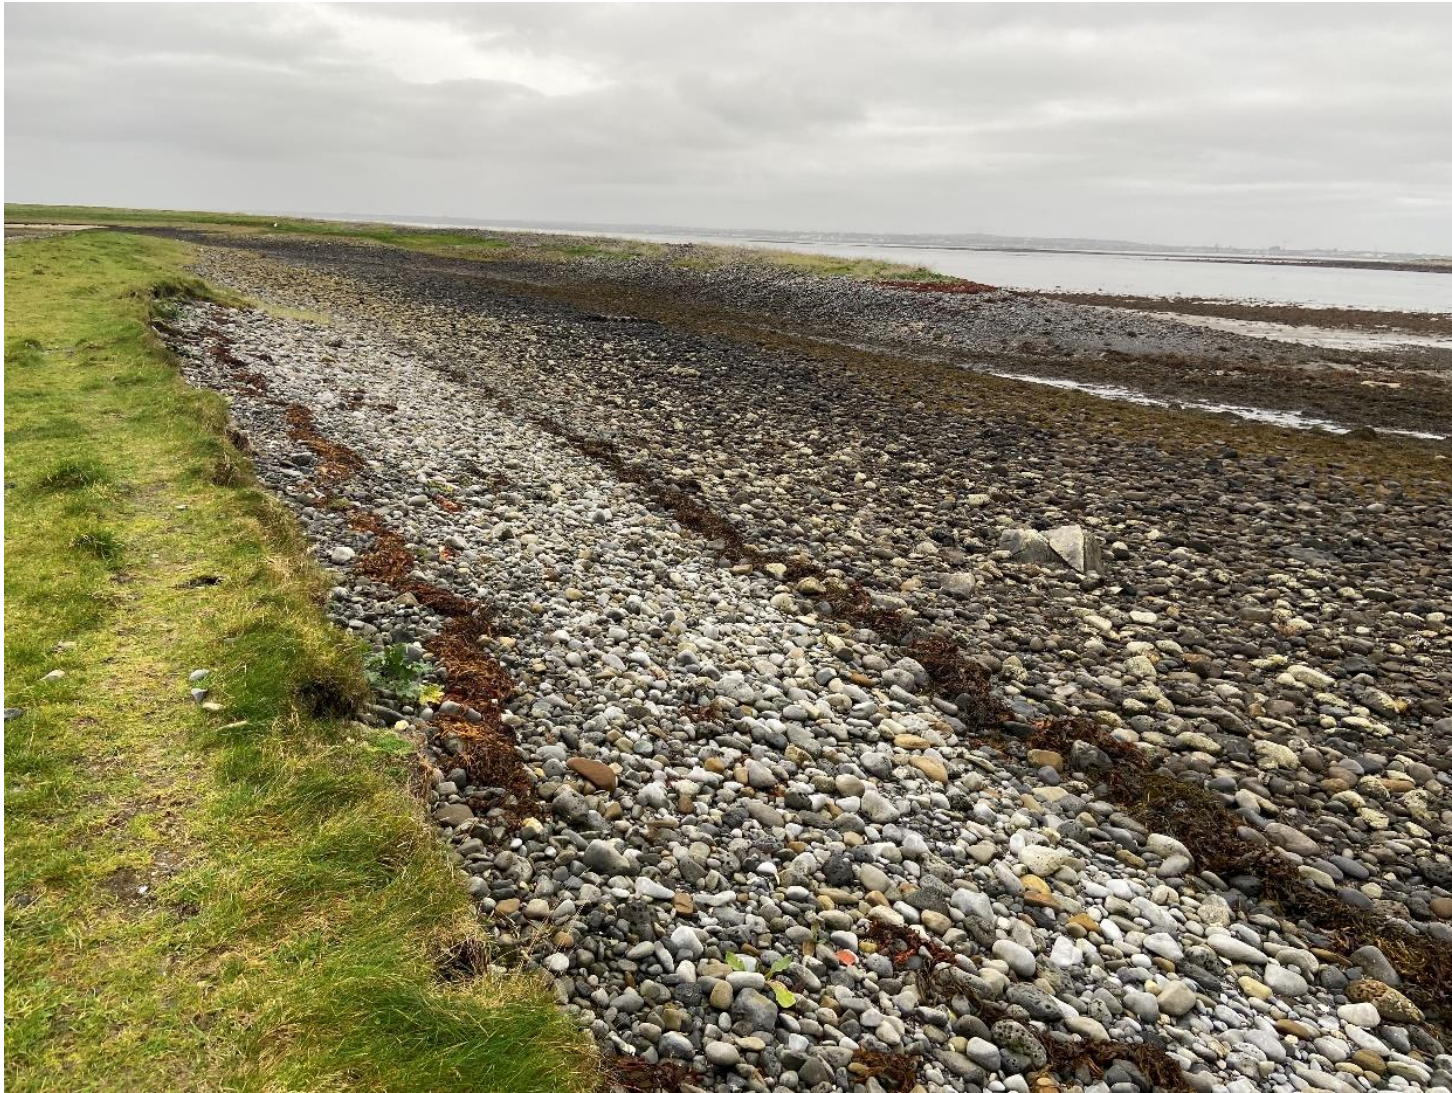
Plate 8. Northeastern channel to Lagoon at Lurgan Island.

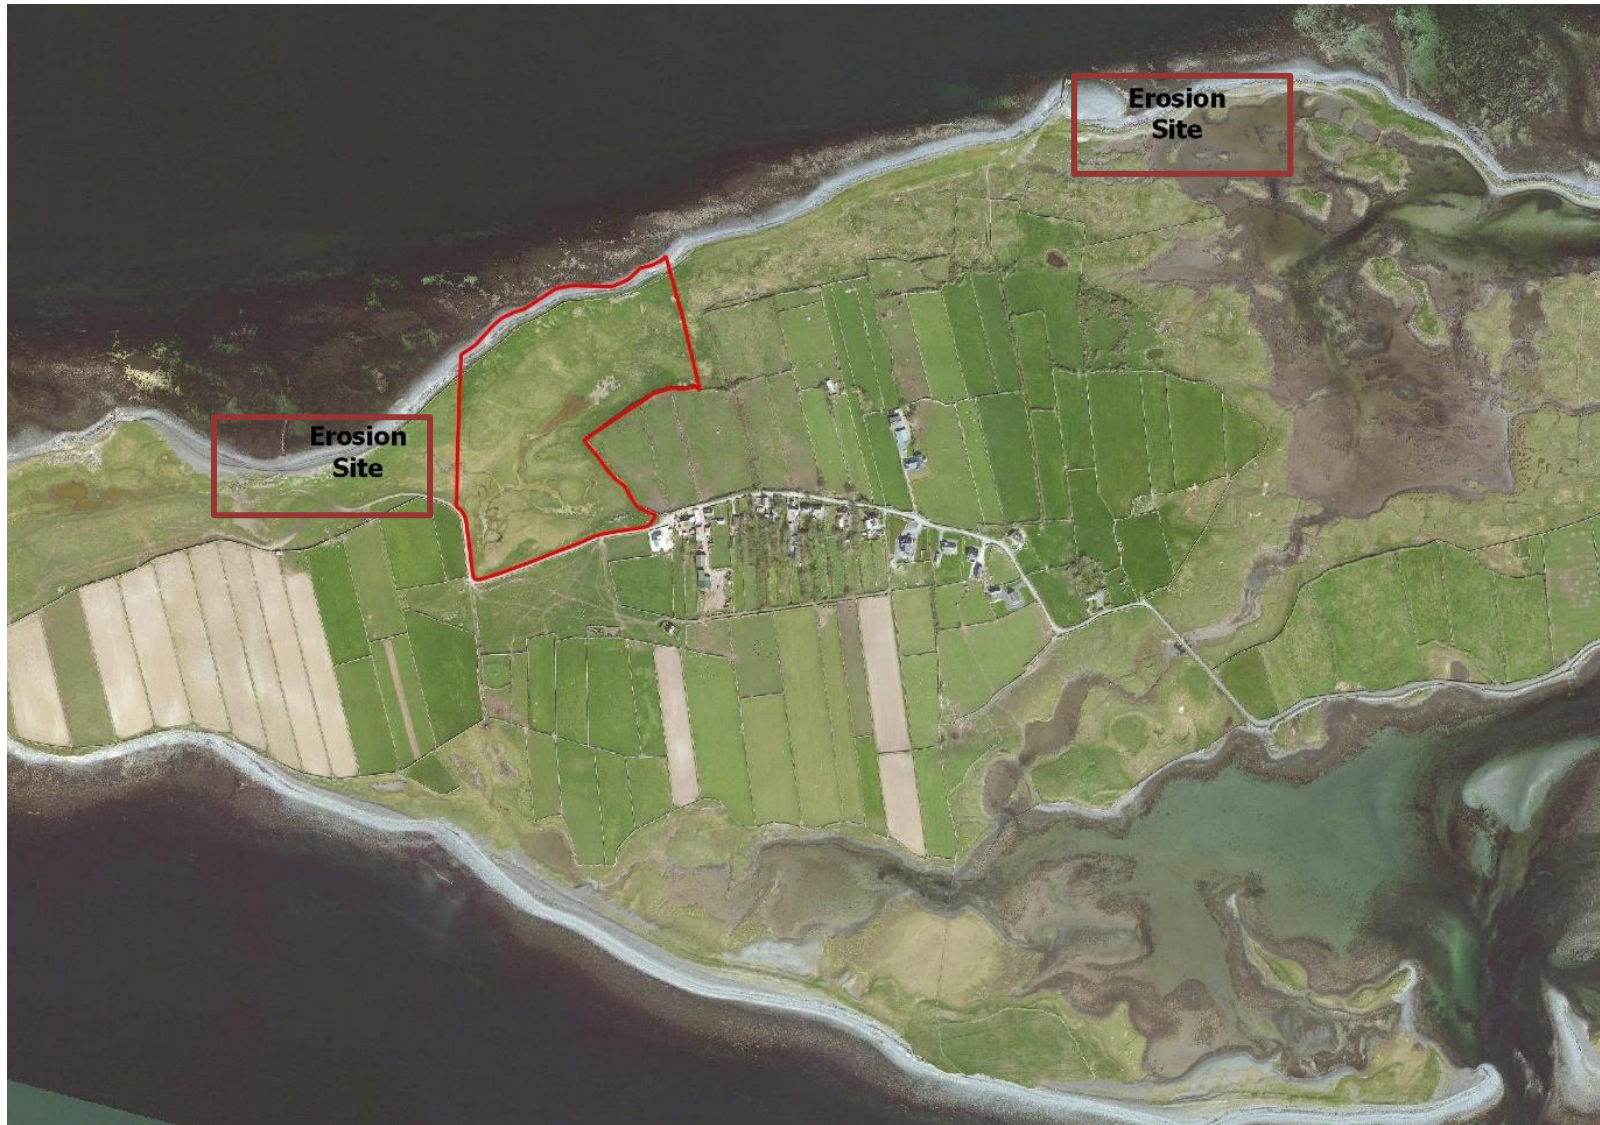
Figure 11-5: Current sites of significant stony bank erosion.

Another site of potentially significant stony bank erosion is located on the lands immediately to the west of the site where the bank appears to have retreated and is displaying significant erosion from wave action, refer to Plate 7. Significant shingle deposition by storm waves is also evident further to the west of this location, refer to Plate 8.
