**RE: PA0033 - Galway Harbour Extension – Renmore and Townparks Townland, Galway
Compensatory Measures Proposal
Response to An Bord Pleanála letter of 20 October 2021**

Response to An Bord Pleanála arising from National Parks and Wildlife Service Queries on Compensatory Measures Plan

Client:	Galway Harbour Company
Project:	Galway Harbour Extension
Title:	Response to An Bord Pleanála arising from National Parks and Wildlife Service Queries on Compensatory Measures Plan

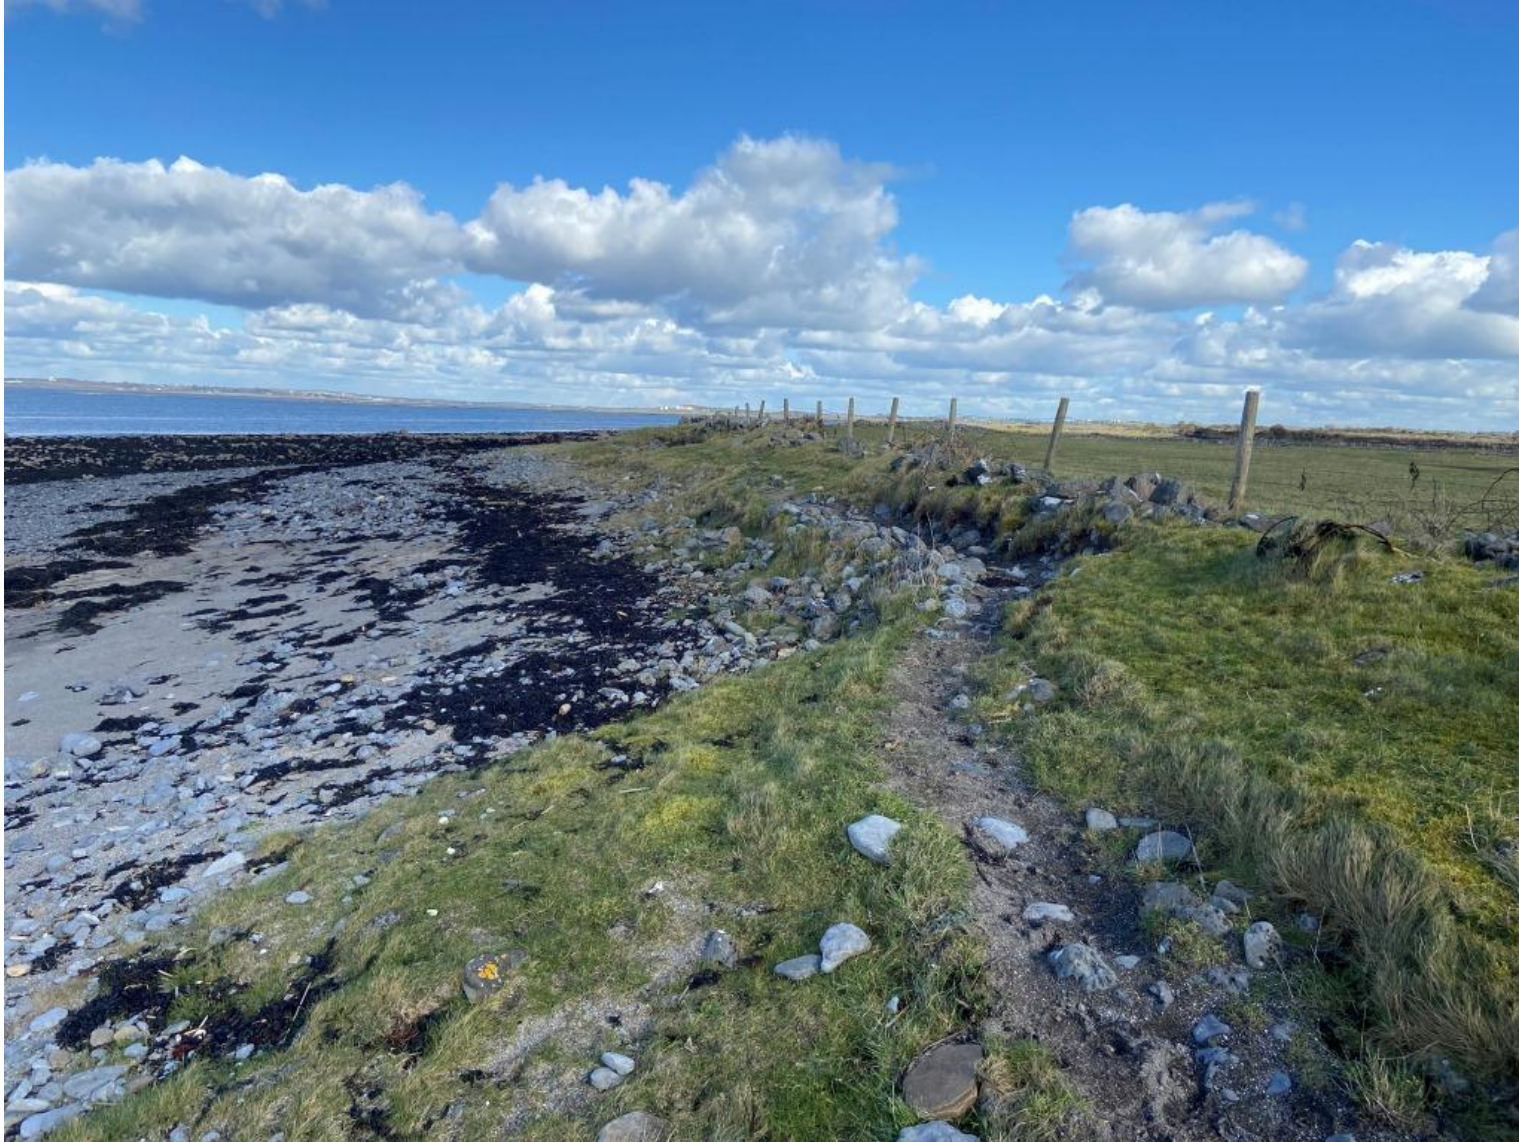
Plate 5. Local Site of erosion on stony bank at subject lands.

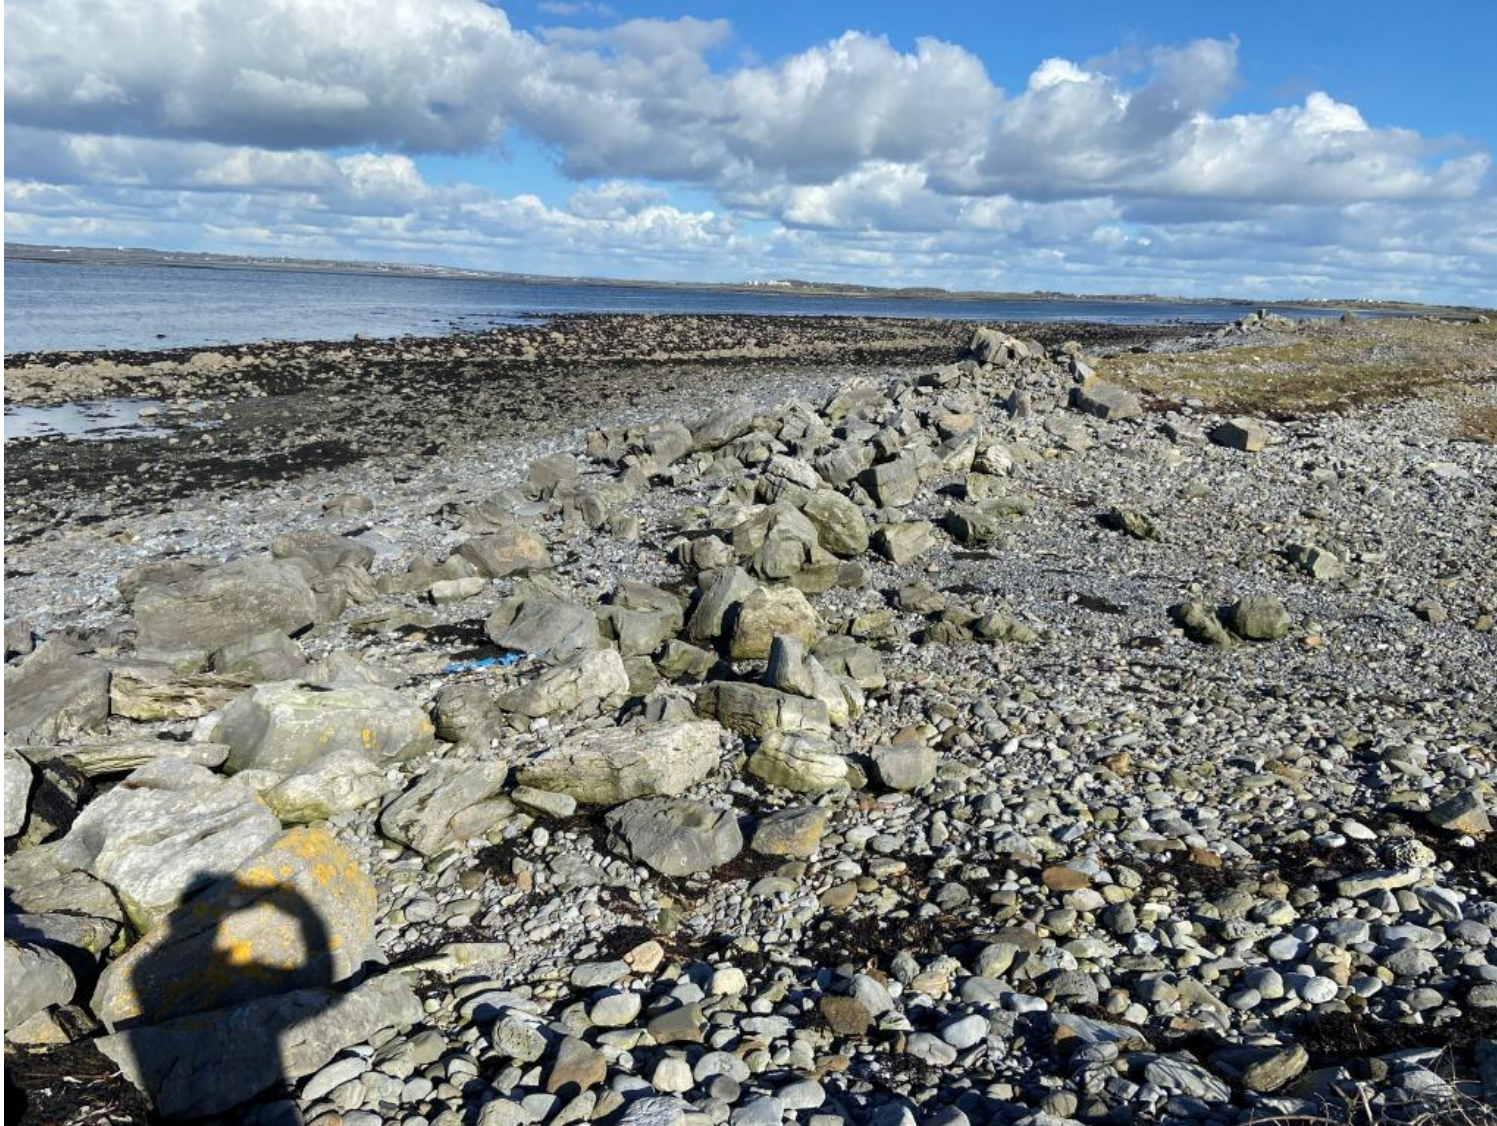
Plate 6. Significant site of bank erosion 600m to the east of the subject lands where rock armour protection had been placed previously (late 90's) but has been undermined and significantly lowered forming ineffective protection.

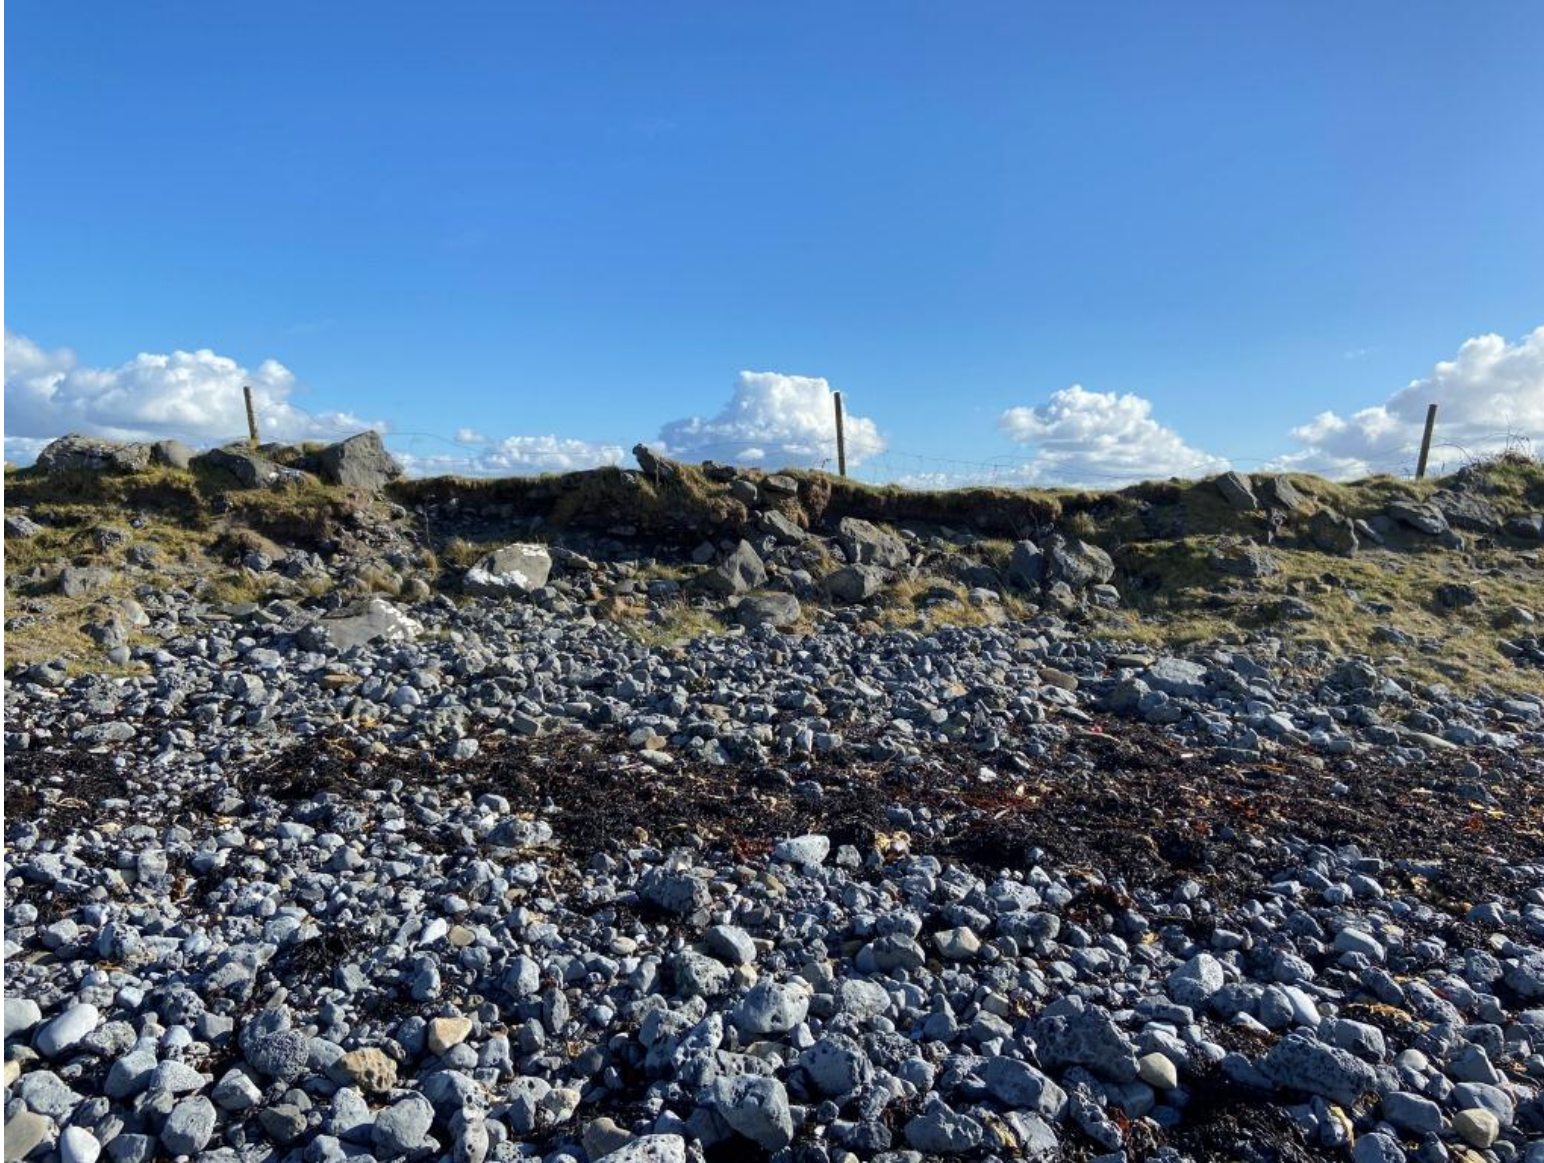
Plate 7. Significant local Bank Erosion 80m west of the subject lands.

Another site of potentially significant stony bank erosion is located on the lands immediately to the west of the site where the bank appears to have retreated and is displaying significant erosion from wave action, refer to Plate 7. Significant shingle deposition by storm waves is also evident further to the west of this location, refer to Plate 8.

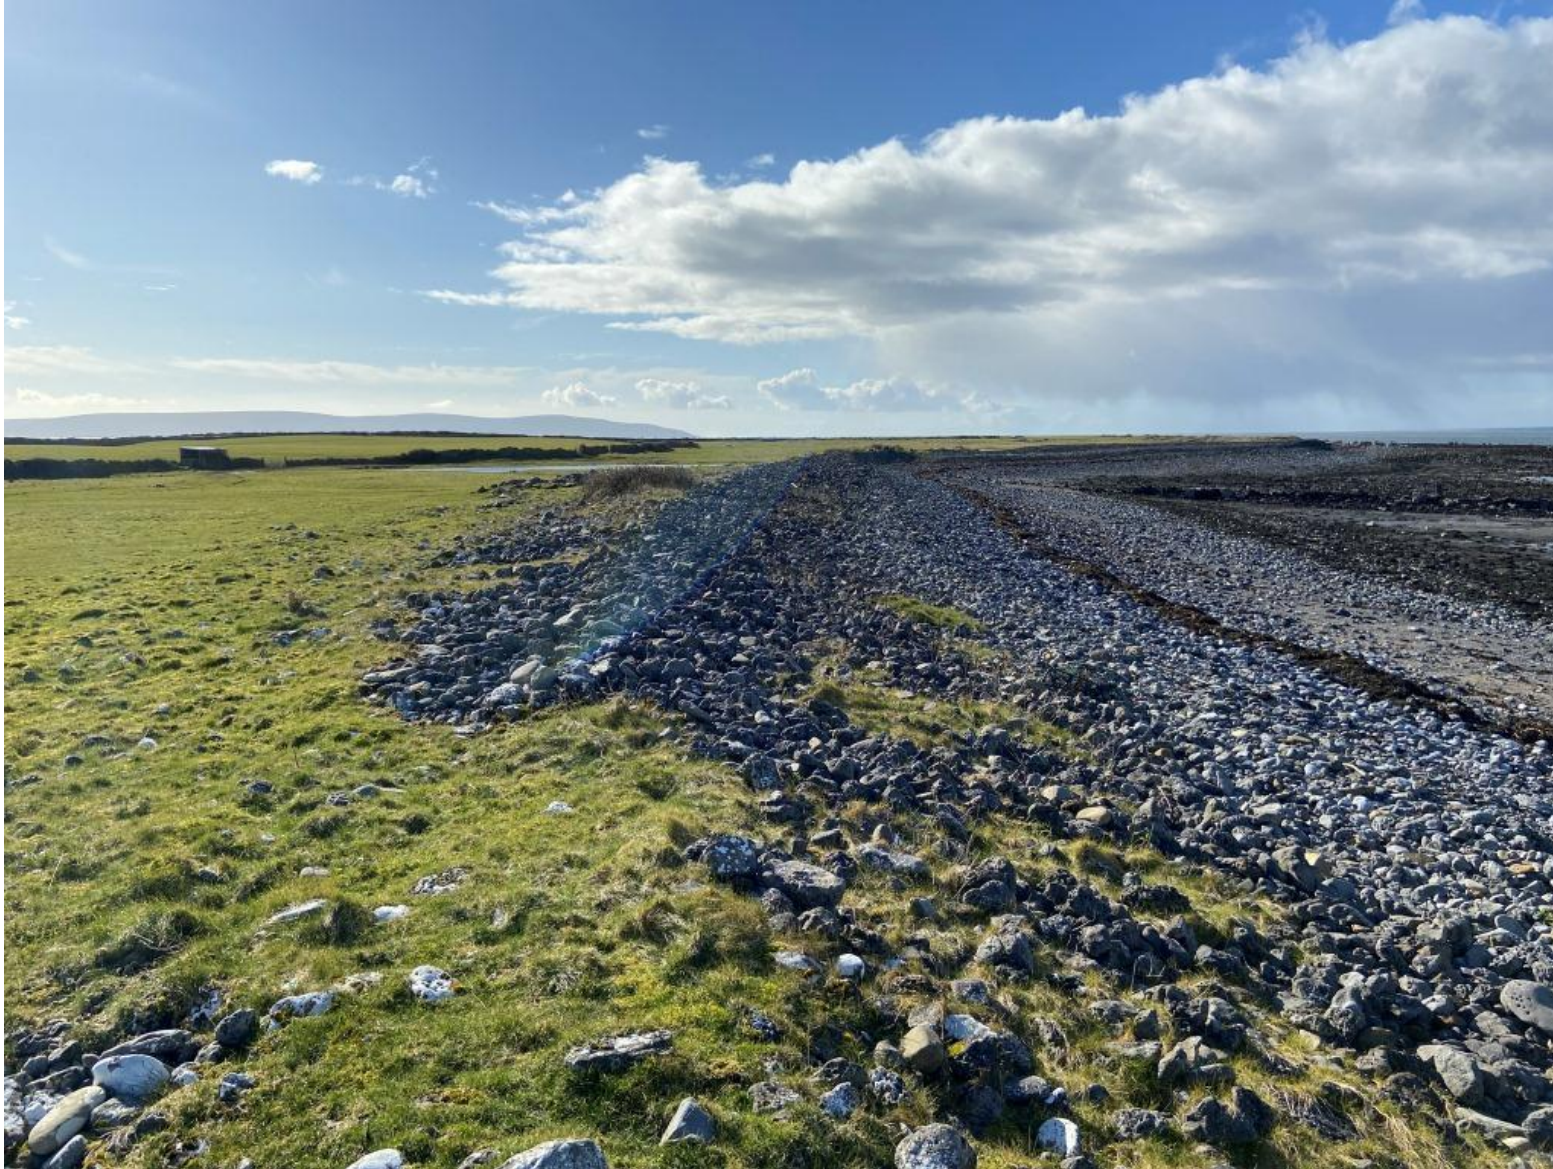
Plate 8. More active section of stony bank with single deposition from storms located 150m from subject lands.

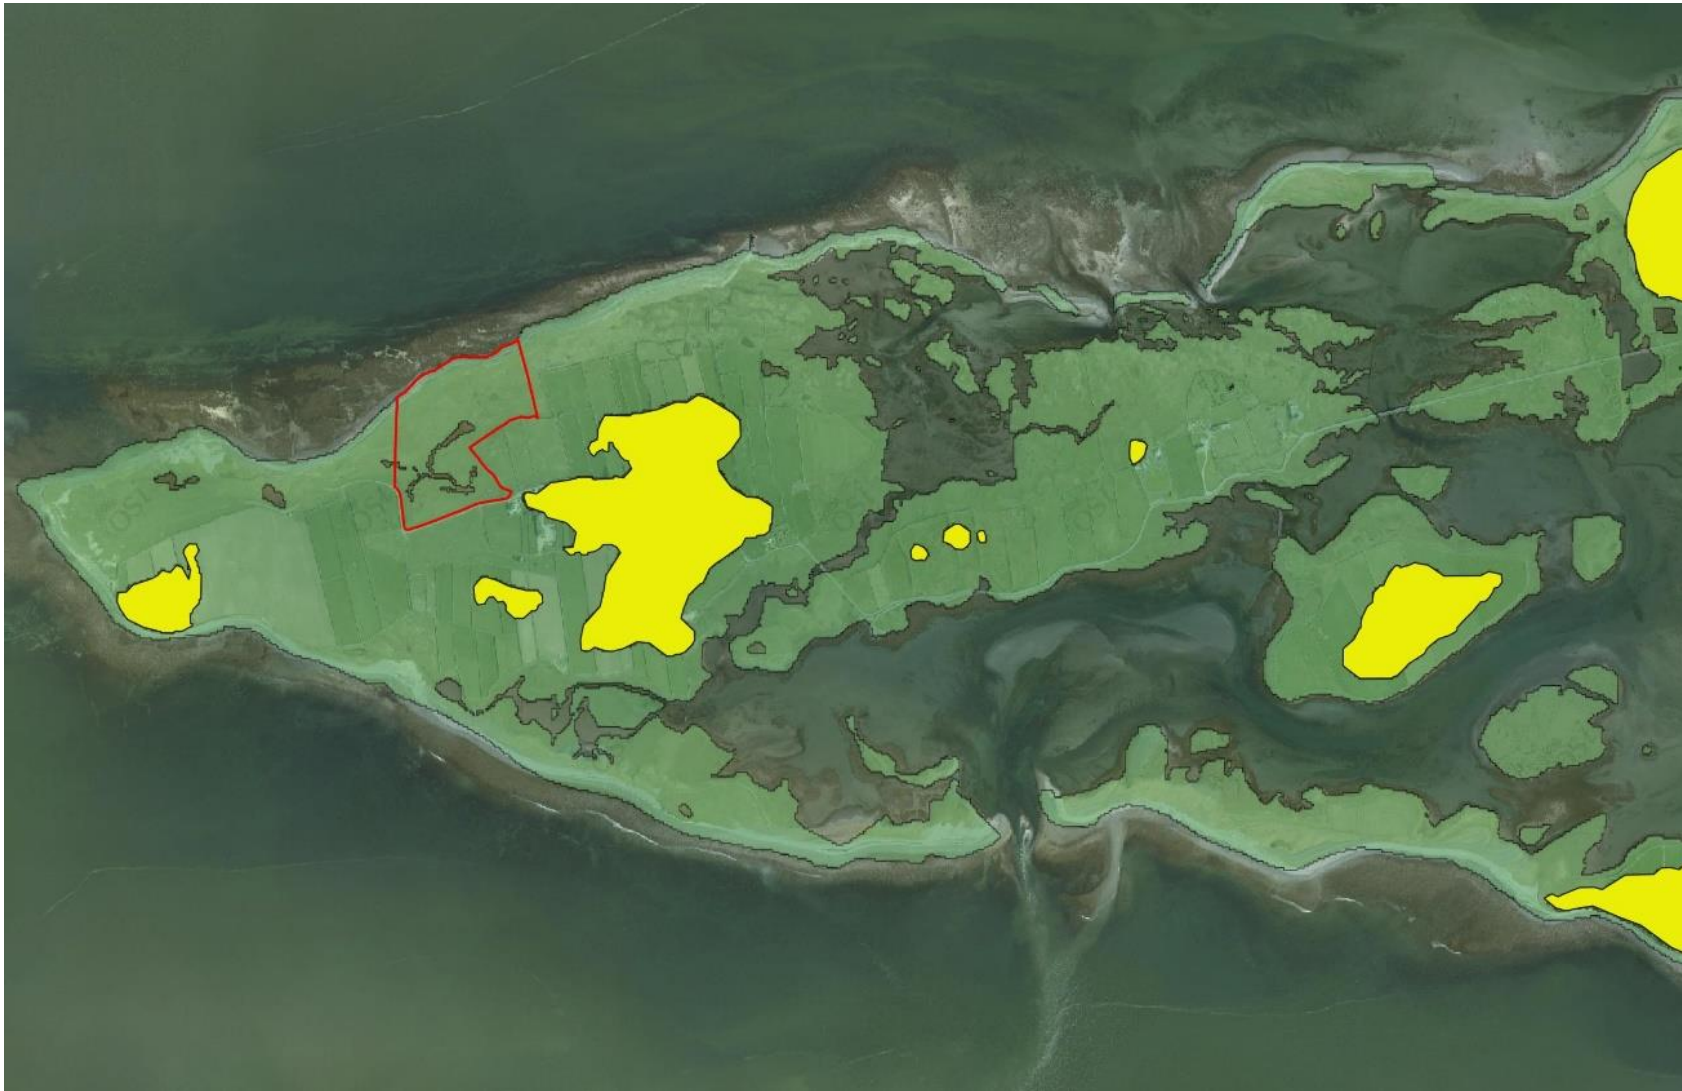
Figure 11-7. Present day flood risk to the Greater Tawin Area highlighted in yellow.

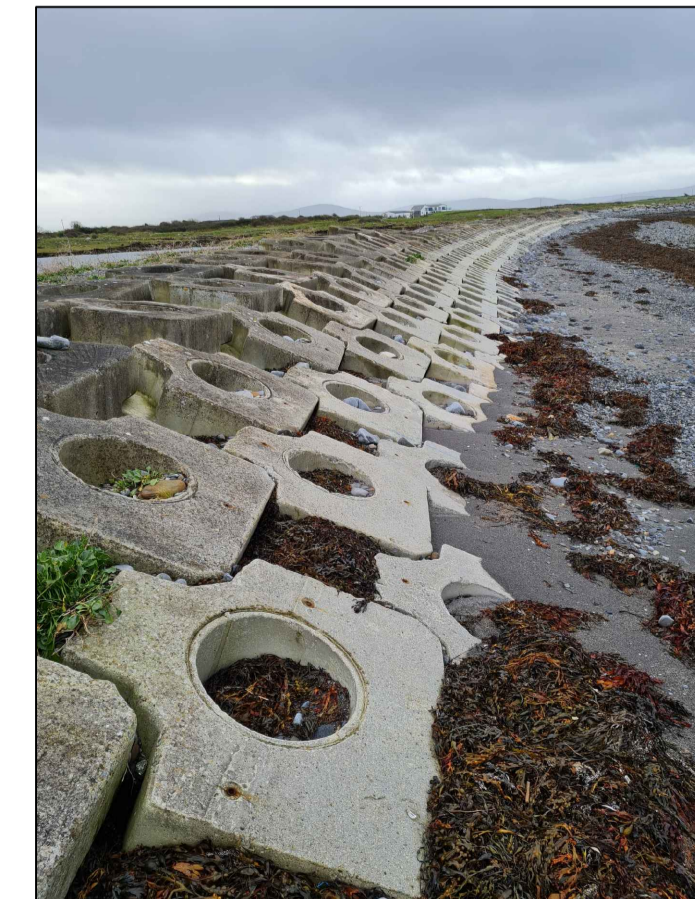
4. Photo November 2021
